**Christchurch Earthquake
CBD Building Performance Technical Investigation**

**Report on the Structural Performance
of the
Hotel Grand Chancellor
in the
Earthquake of 22 February 2011**

Prepared By:
Dunning Thornton Consultants Ltd

Final: 26 September 2011

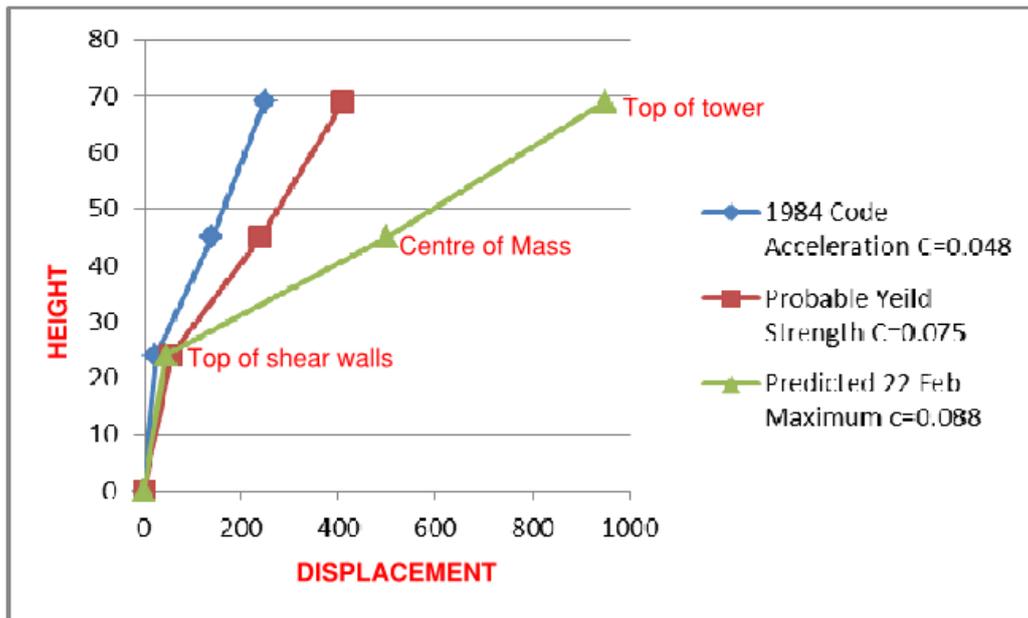
Fig.7

Displacement of effective centre of mass	500mm
Displacement at top of shear walls	70mm
Ductility demand on shear wall structure	1 – 1.5 depending on wall length and axial load
Displacement at top of tower	950mm
Ductility demand on upper tower	3.3
Effective ductility demand on overall structure	2.9
Average drift in upper tower	1.9% (65mm/floor)

This response (ignoring the failure) is similar to what is implied by the 1984 loadings code (NZS4203:1984). While the initial accelerations and displacements for a 3 second period structure were higher in the February event than implied by the code, as the structure yielded and softened the demands were similar.

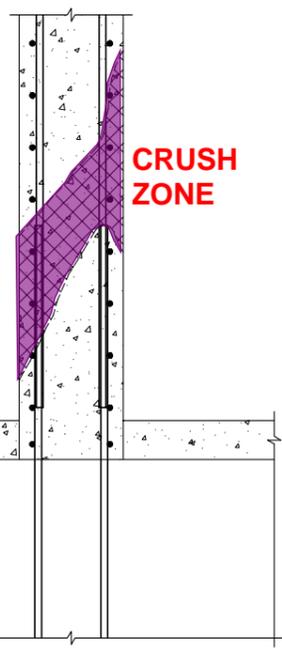
CROSS-SECTION SHOWING FAILURE MODE

ZONE OF BRITTLE FAILURE

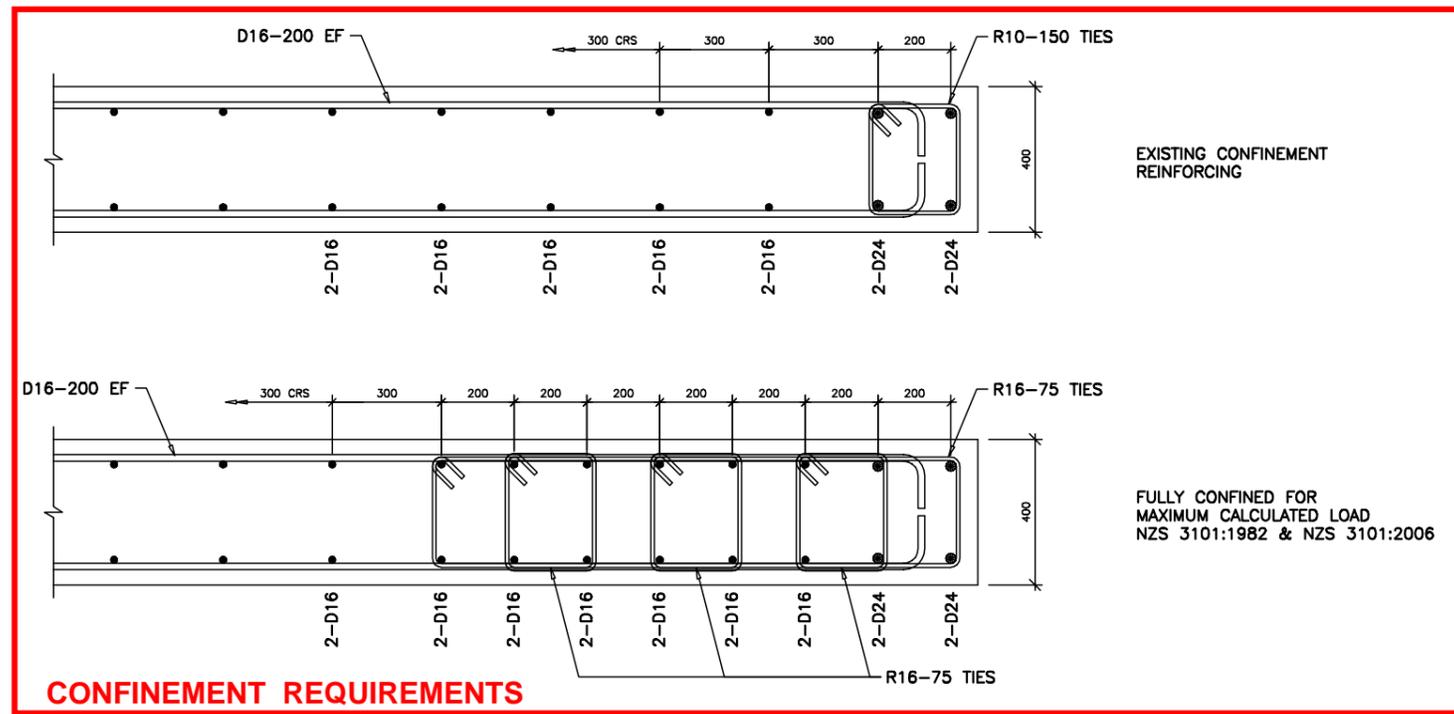
WALL D5-6

LAP FAILURE

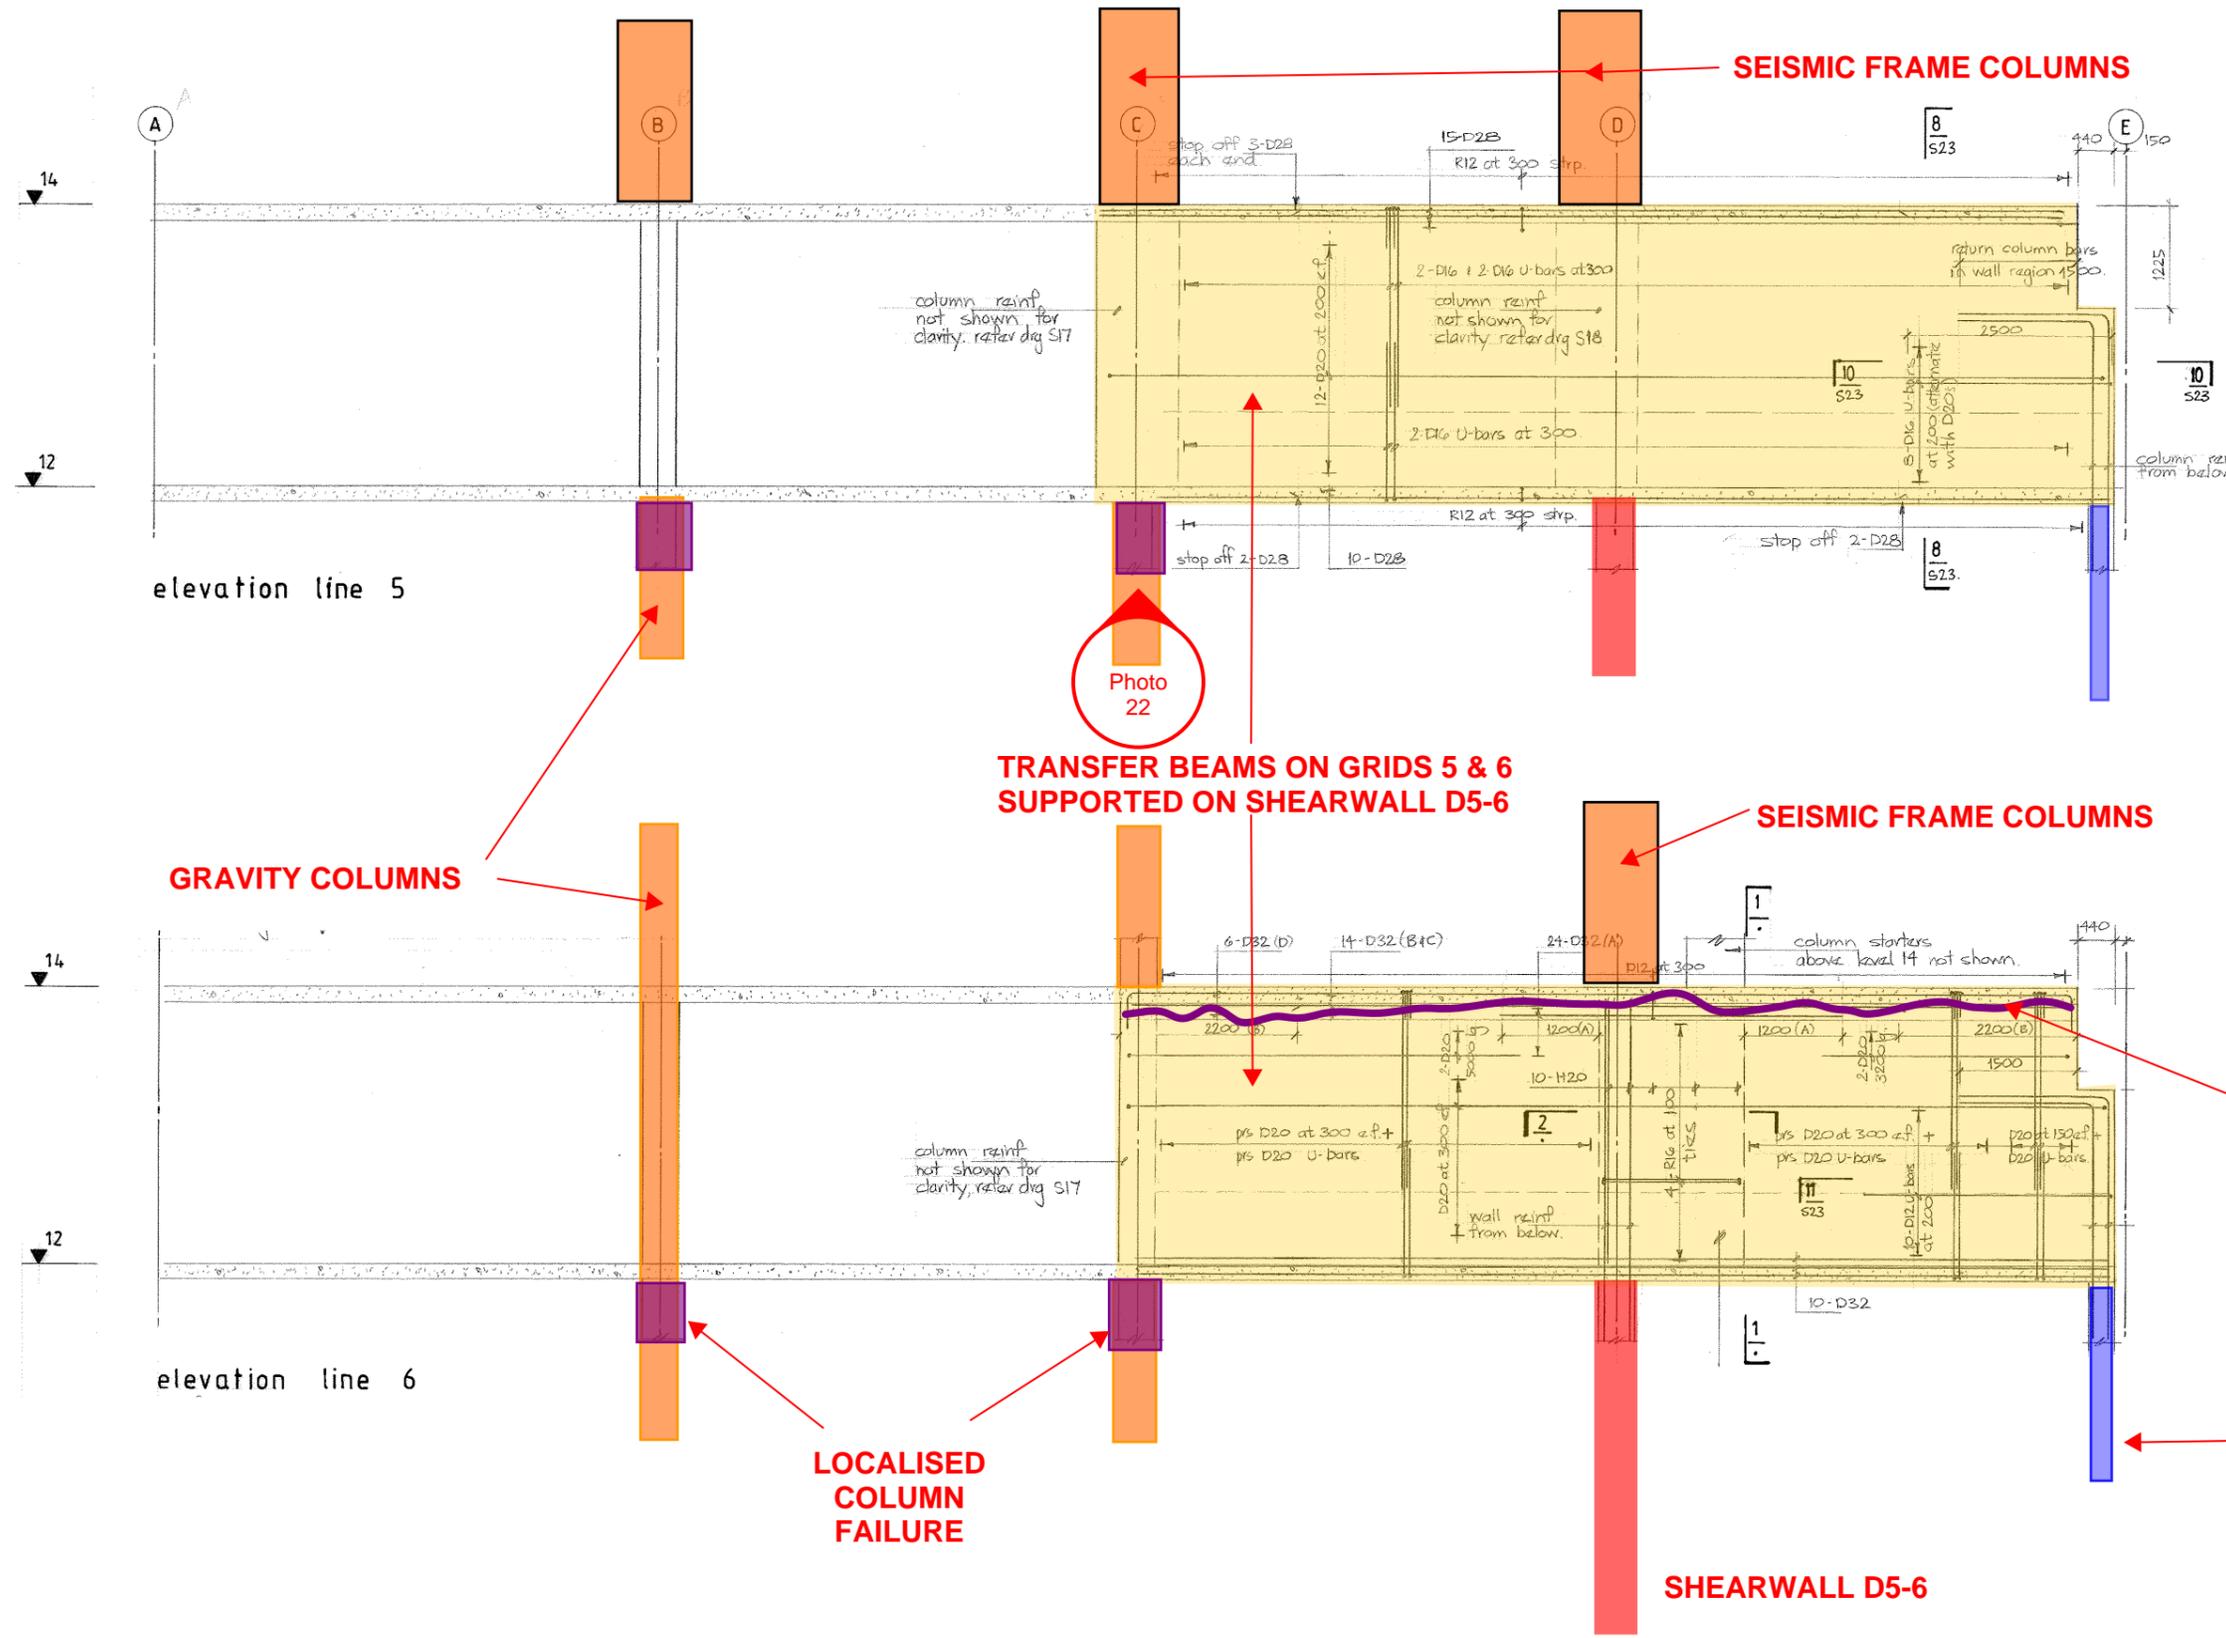
SHEAR YIELDING IN DIAPHRAGM SLAB

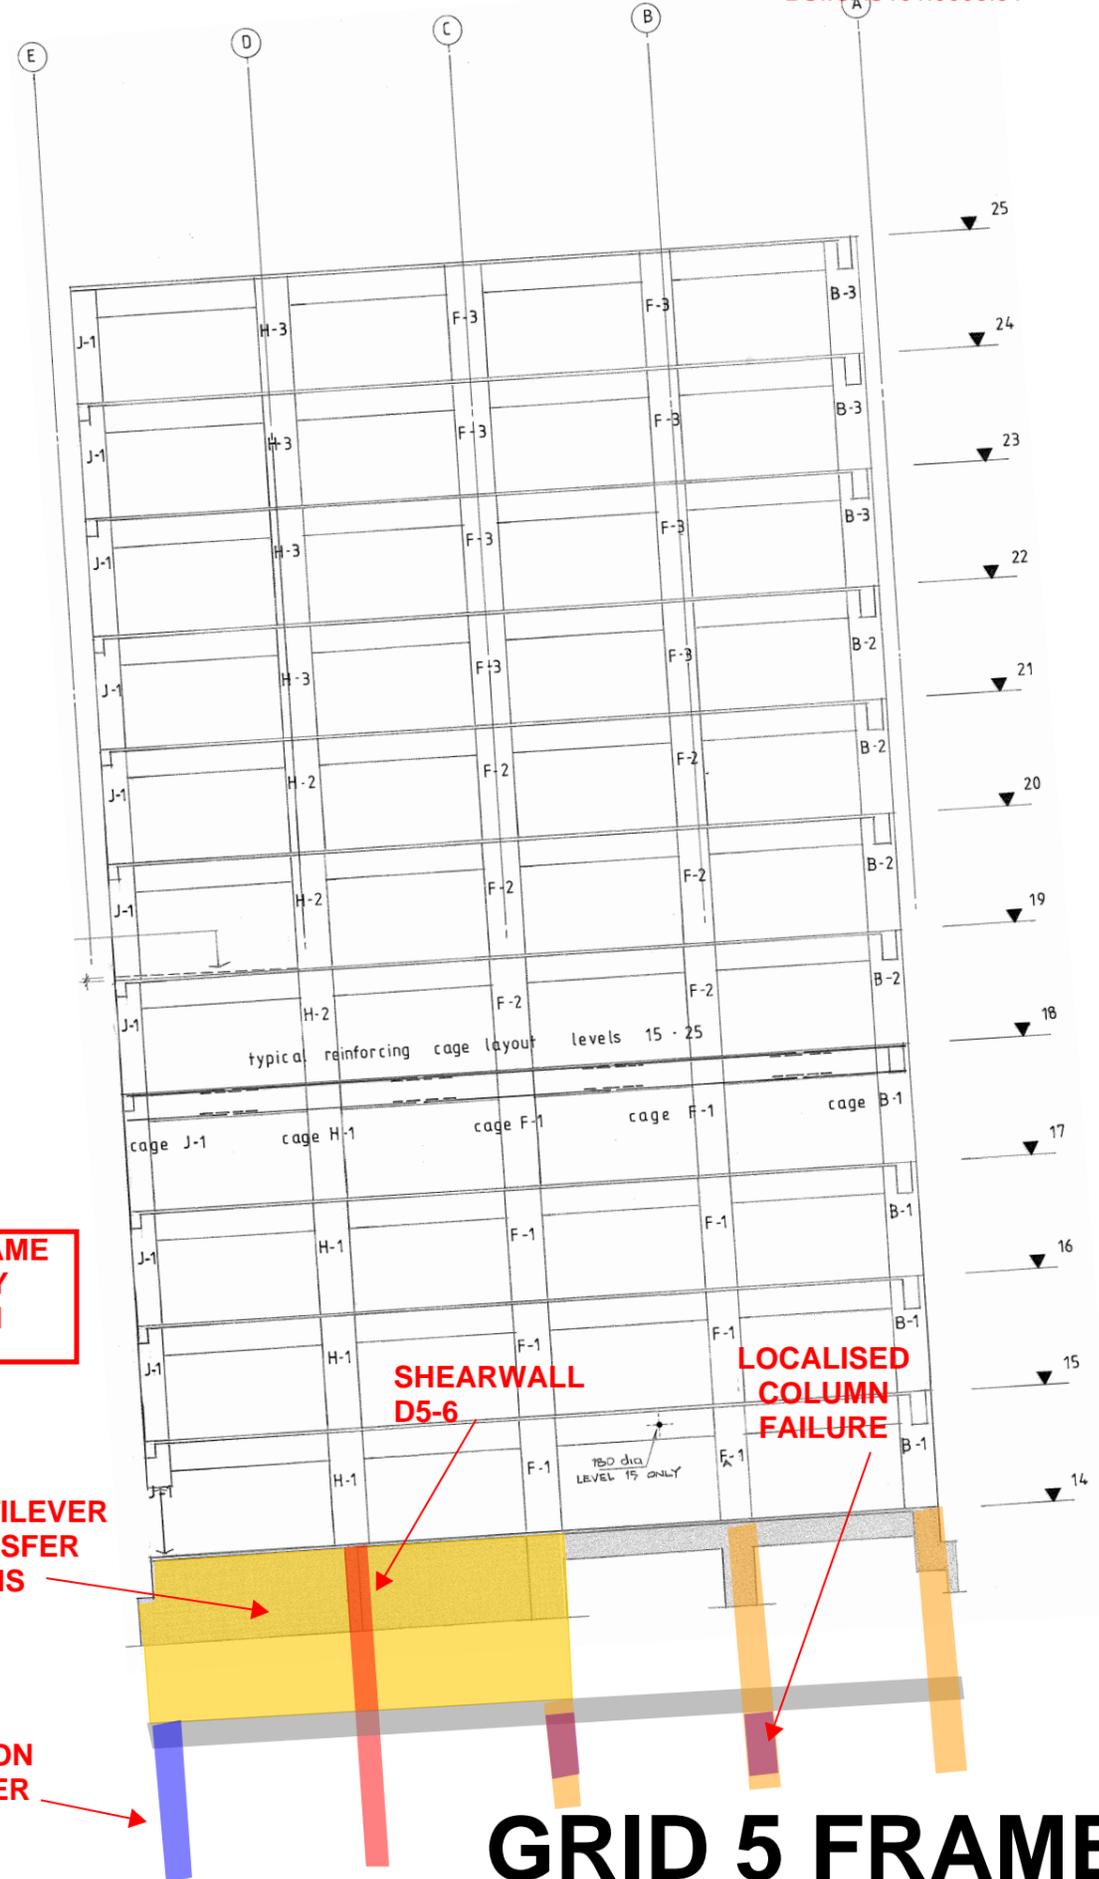
**GRID 5 SEISMIC FRAME
POST FEBRUARY
LOOKING SOUTH**

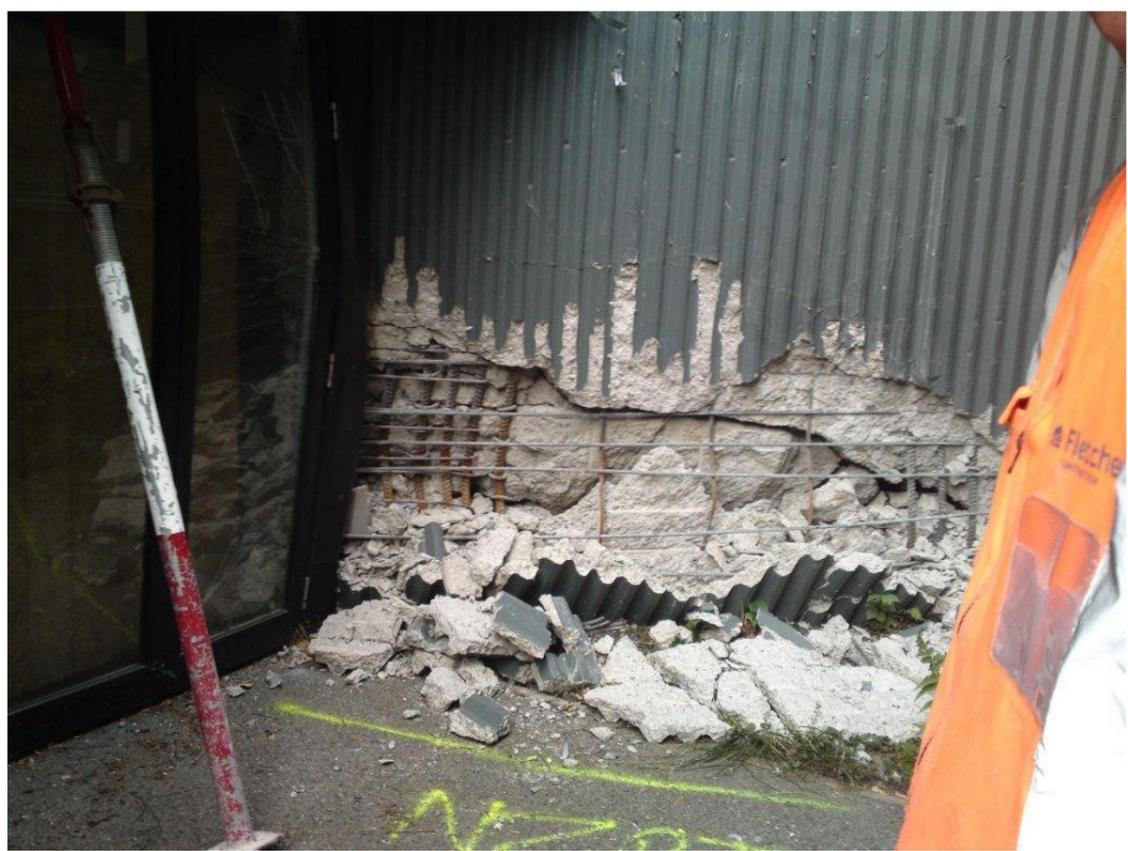
Photo 10 - Shearwall D5-6 Failure - Close-up

- It is likely that the diagonal failure plane initiated immediately behind the small confined zone, at the top of the lapped bars, possibly encouraged by a tension yield crack and/or by stress raisers at the top of the web laps. This is consistent with photographic evidence that shows the top of the failure plane coincident with the top of the lap bars. [Ref App C Photo 10]

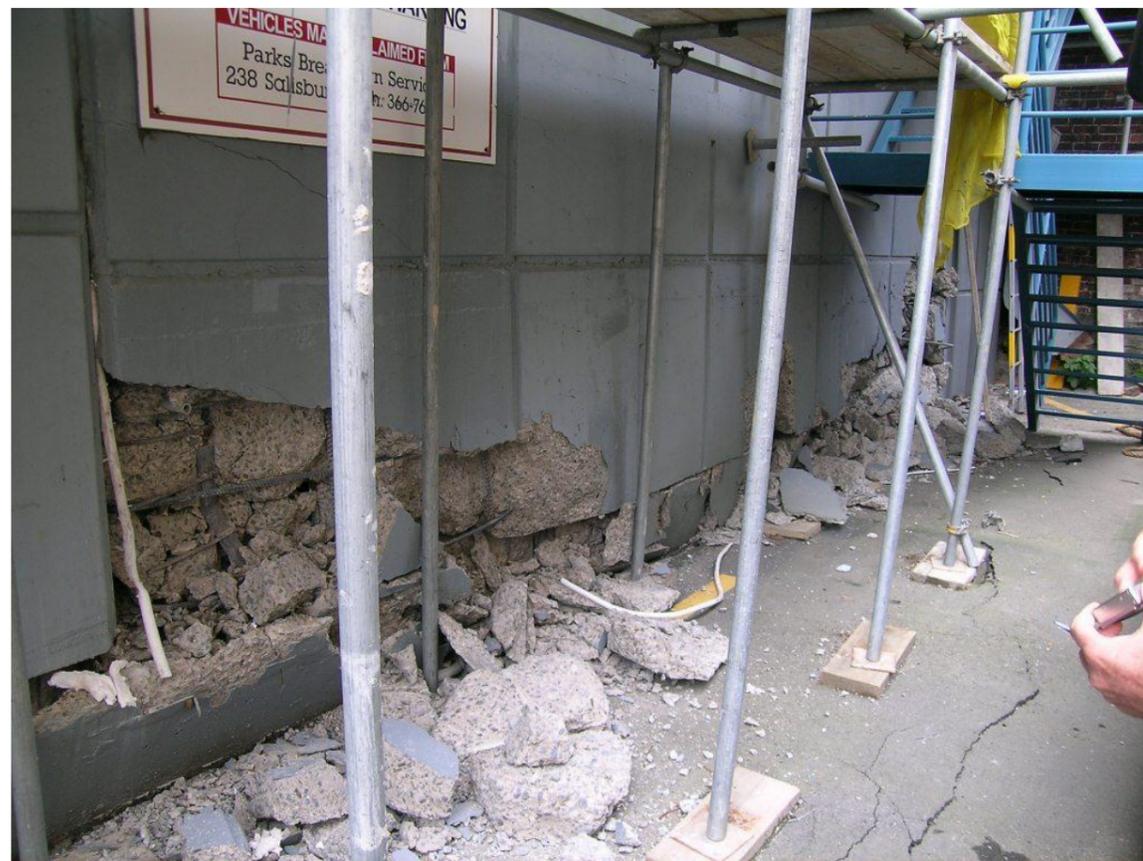
Photo 13 - Folded slab at level 2

Between grids D and E there is a non-structural wall that separates the hotel lobby from Tattersalls Lane. This wall is parallel to the shear wall D5-6 and lies approximately midway between D and E. As the corner subsided, there was sufficient vertical load carrying capacity in the non-structural wall to break the back of the level 2 slab. *[Refer App. B page 7 & App. C Photograph 13]*
