# Canterbury Earthquake Royal Commission Hearings - 17 Jan 2012

## Seismic Performance of the Hotel Grand Chancellor : Findings and Recommendations

**Stefano Pampanin**

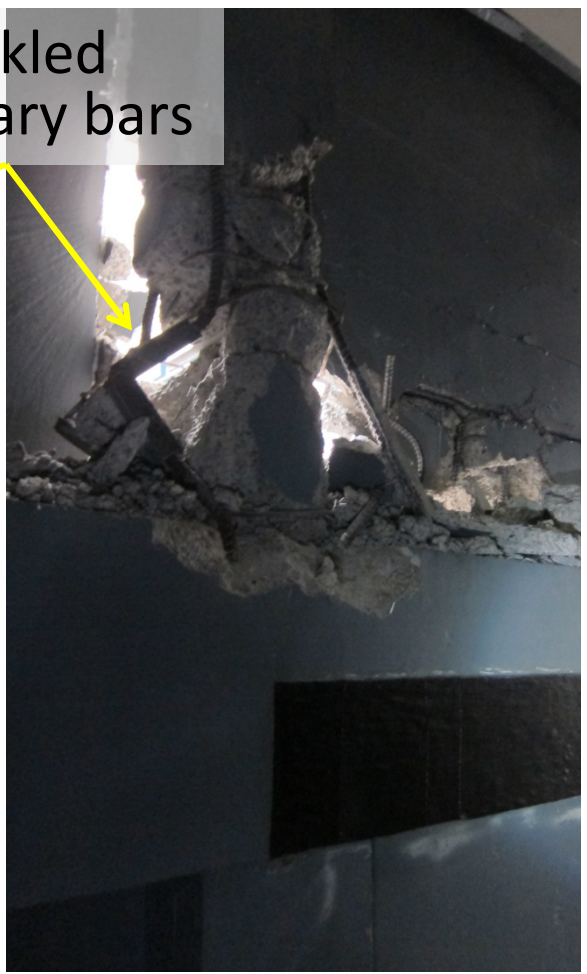
# RC walls (9 storey 1980s)

- These walls, while detailed for flexural action, **failed in brittle shear-compression (in some cases likely to be exacerbated by vertical acceleration effects)** or premature reinforcing tensile/compressive fracture, leading to an irreparable state of the buildings.
- The high number of **severely damaged modern RC wall buildings** has indicated that the current design for slender RC walls **with inadequate confinement steel outside the confined boundary zone, irregular shapes**, or with inter-panel grouted (poorly confined) lap-splice is inadequate.

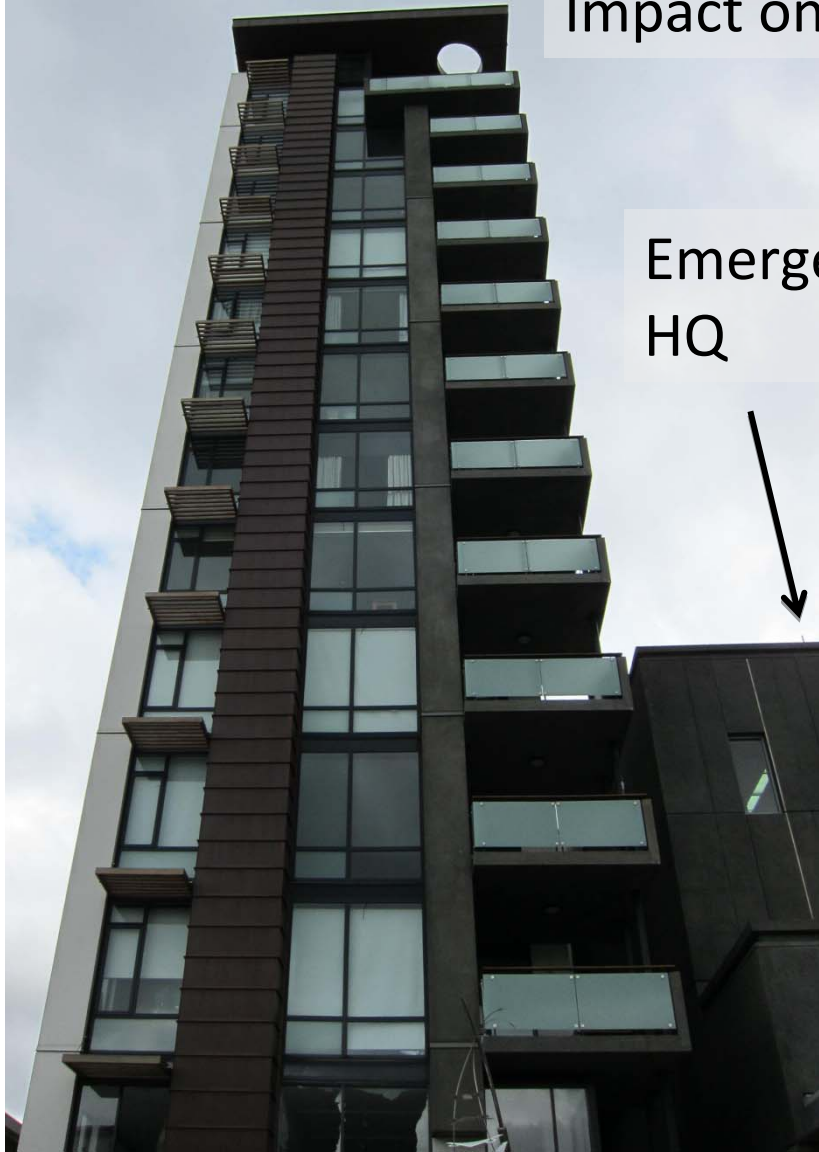
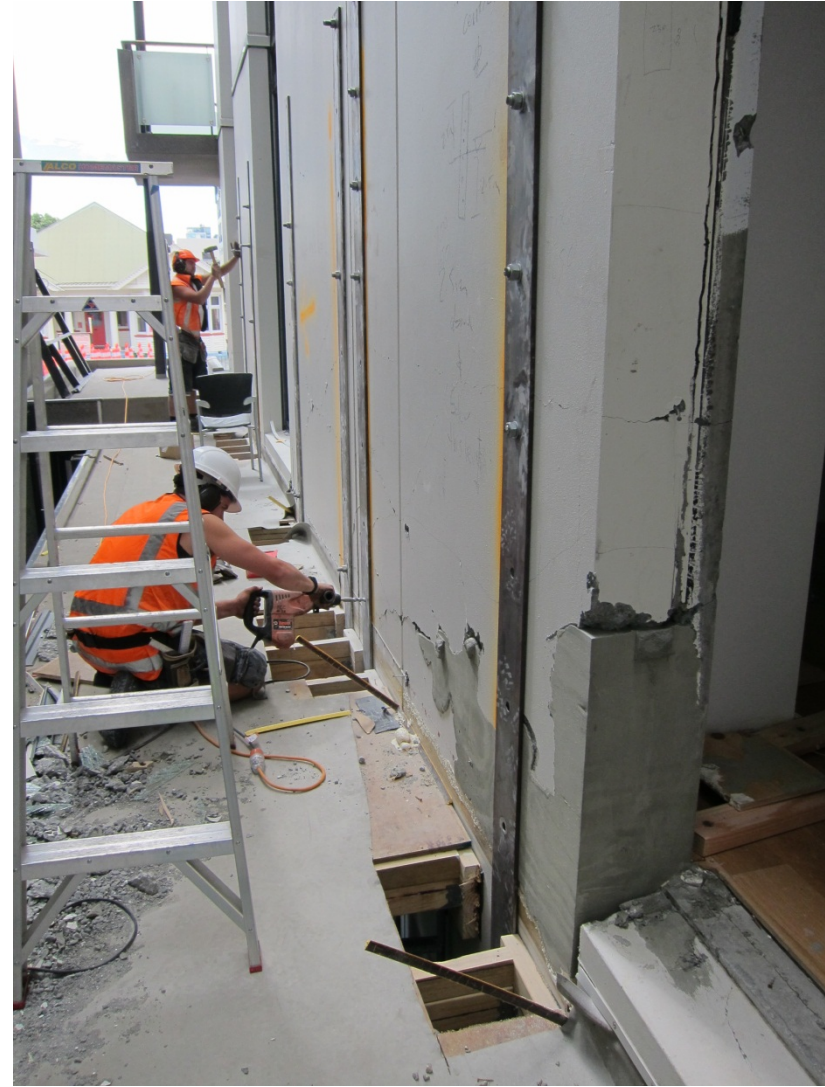
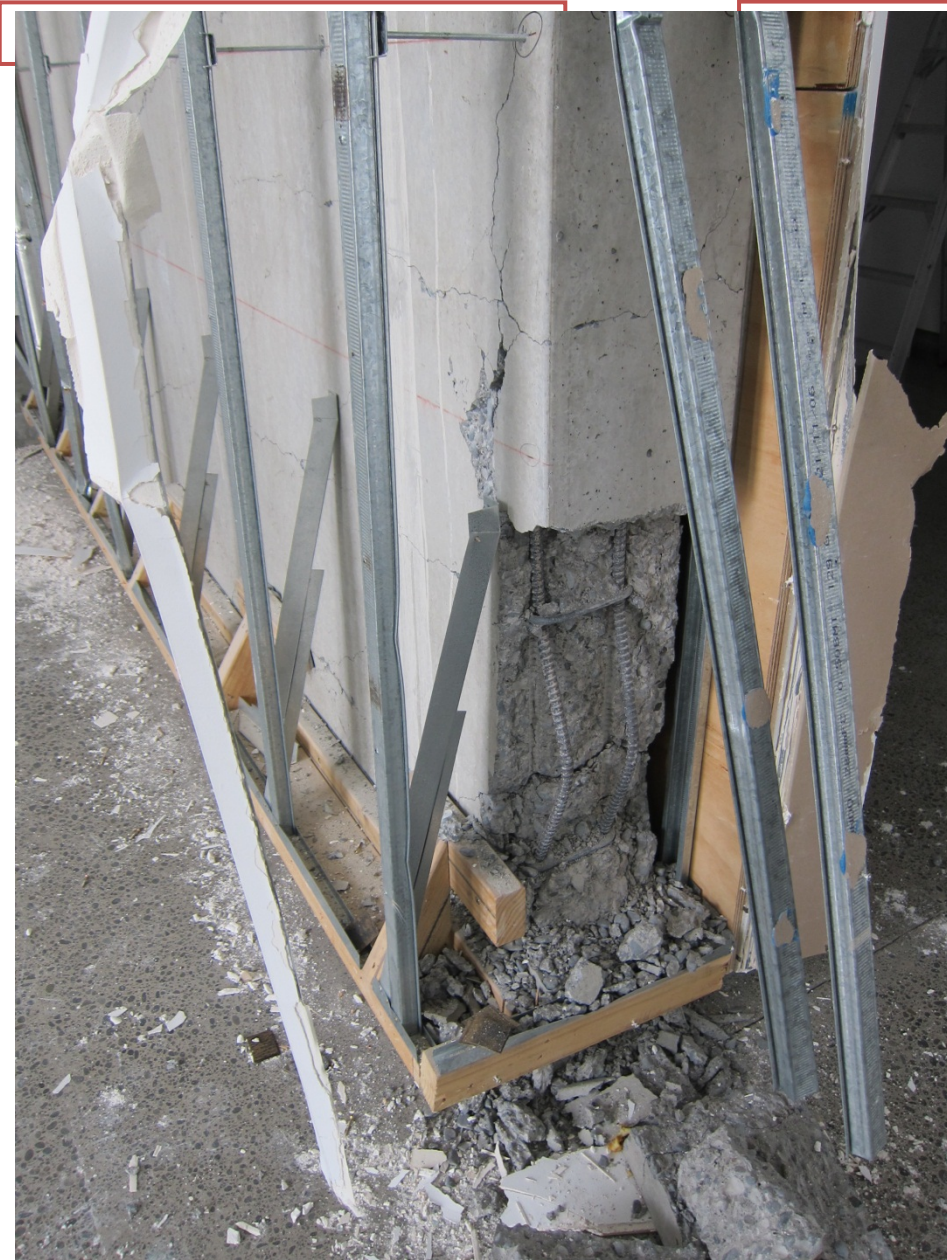
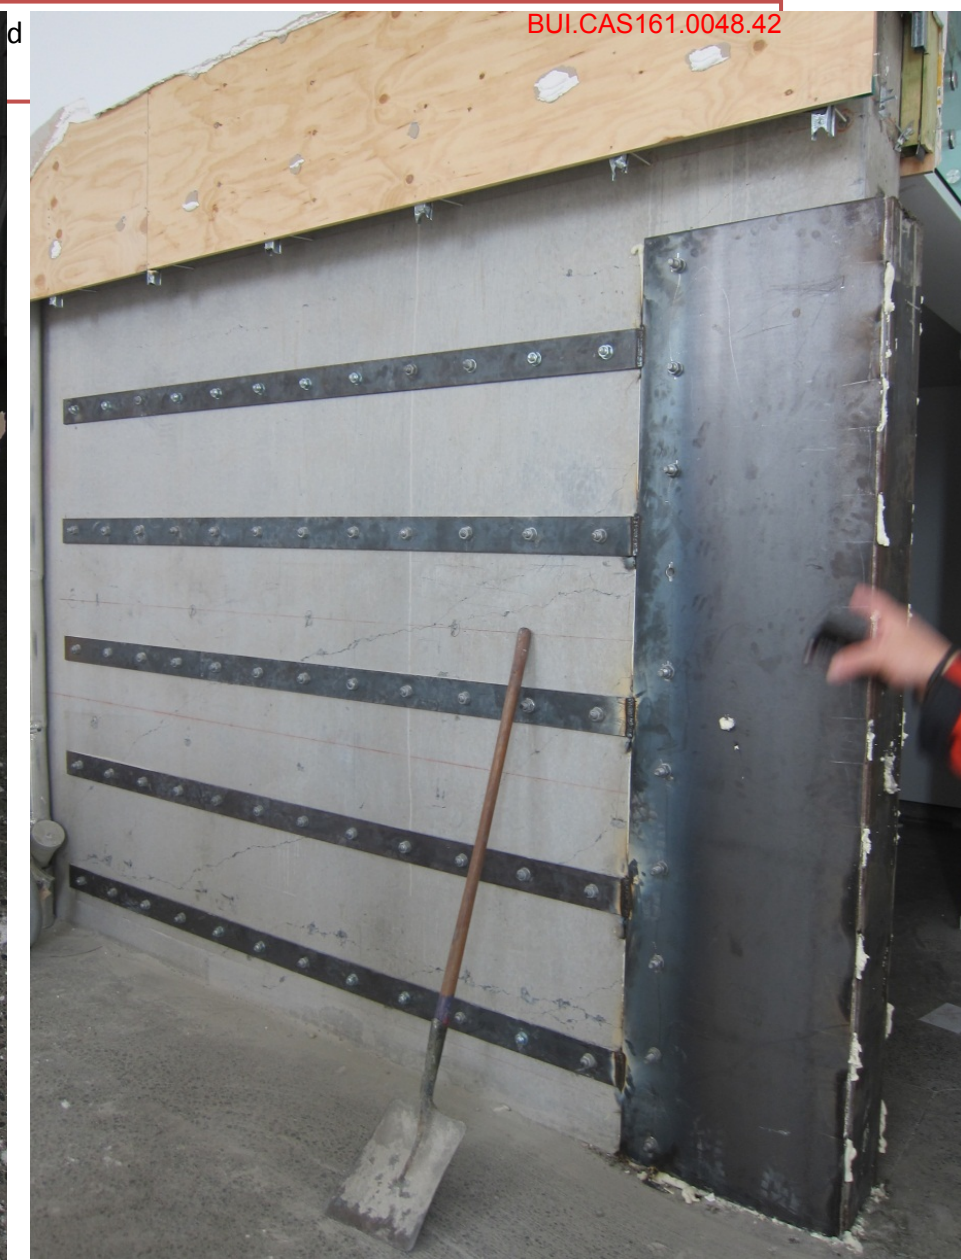
# Impact on neighbouring building

Emergency HQ

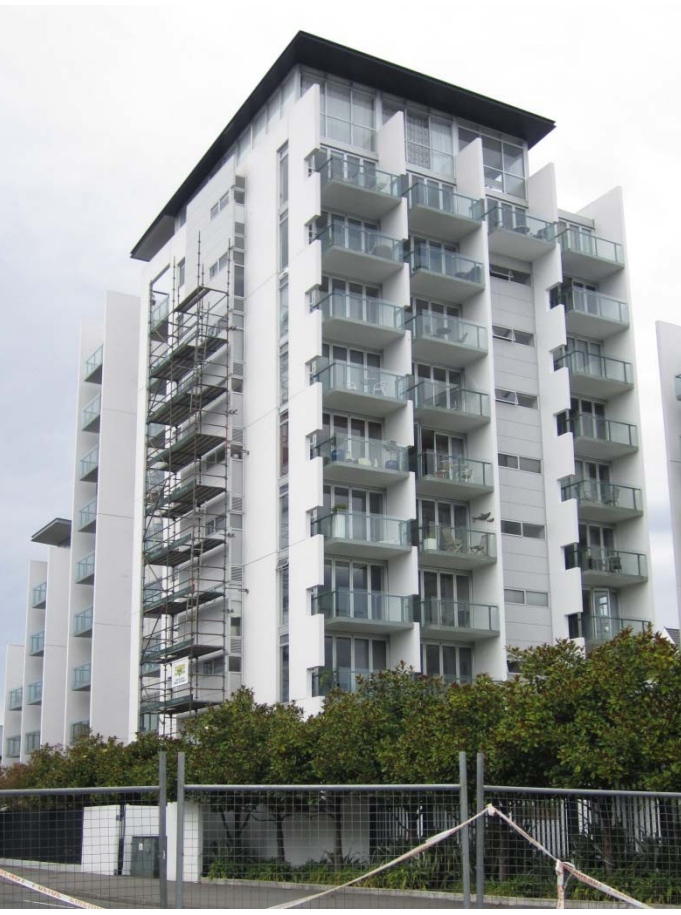
# Slender RC walls

15m long  
200mm thick  
T-shape wall

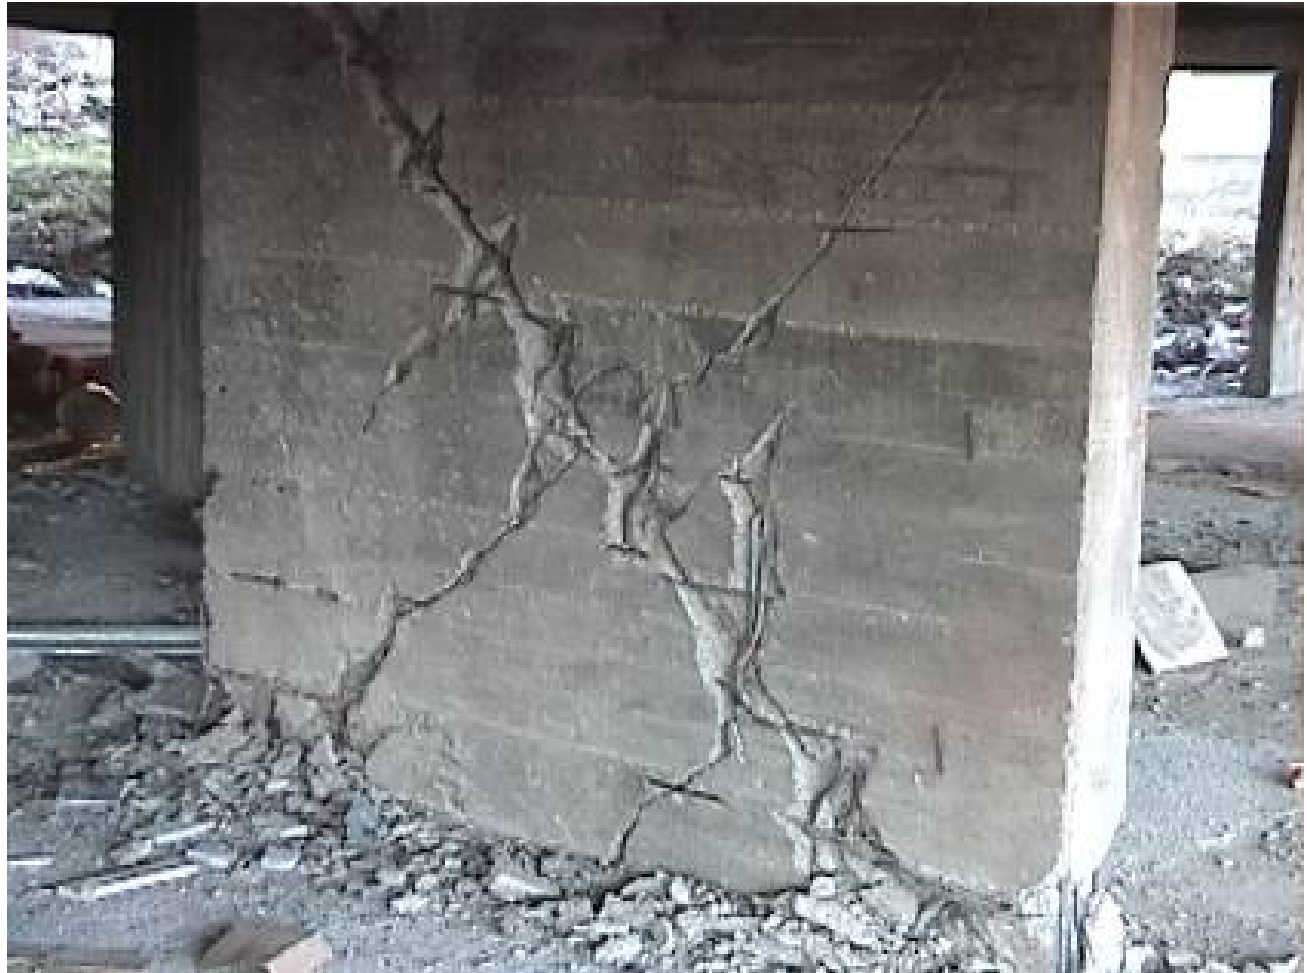
**Bolu, Turkey 1999**

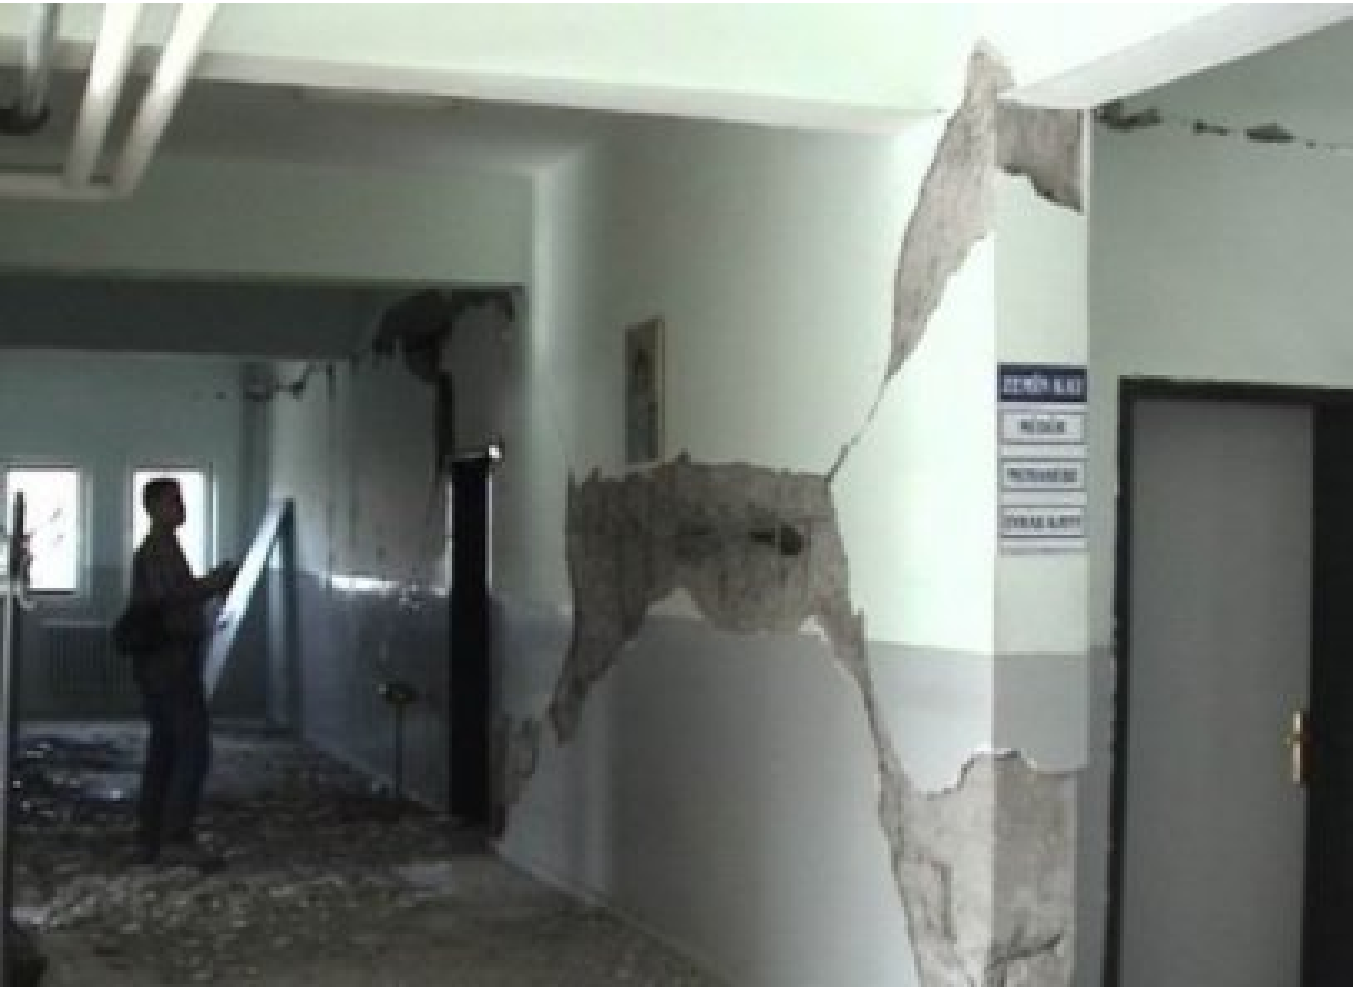
**Bingol, Turkey 2003**
