| C1 TOWER |

This Detailed Engineering Evaluation Report (Report) has been prepared in connection with damage suffered by the building at the address shown on the front of this report (Building) resulting from the earthquakes that occurred in the Canterbury region on Saturday 4 September 2010, on Tuesday 22 February 2011, Monday 13 June 2011 and Friday 23 December 2011 (NZDT) and subsequent aftershocks up to the date of inspection by CPG.

The Pacific Tower Body Corporate via Fortis Construction Ltd engaged CPG to prepare this assessment of damage caused by the 2010/2011 earthquakes and prepare repair specifications as detailed in the CPG proposal dated 7 July 2011.

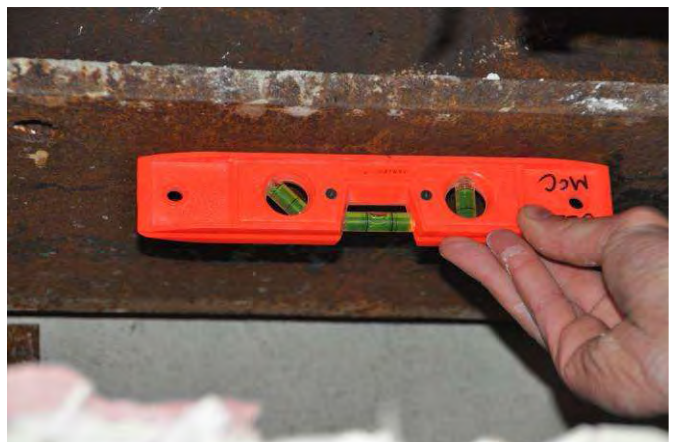
L6, Grid C2, no offset

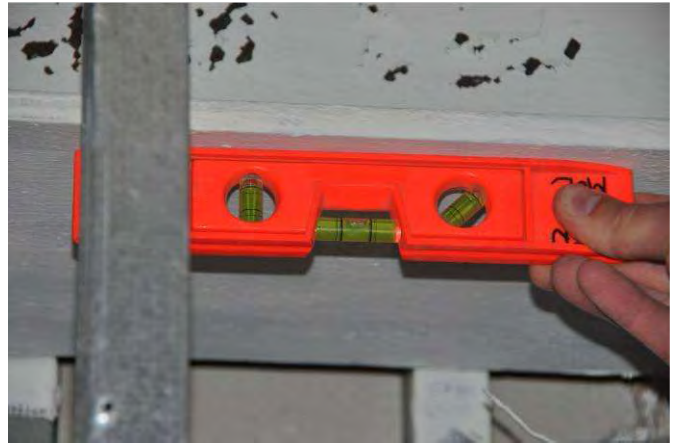
L6, Grid D4(east), no offset

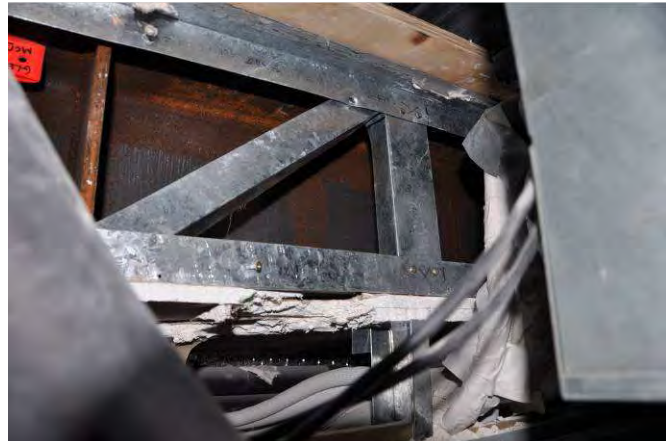
L6, Grid C1/26 active link

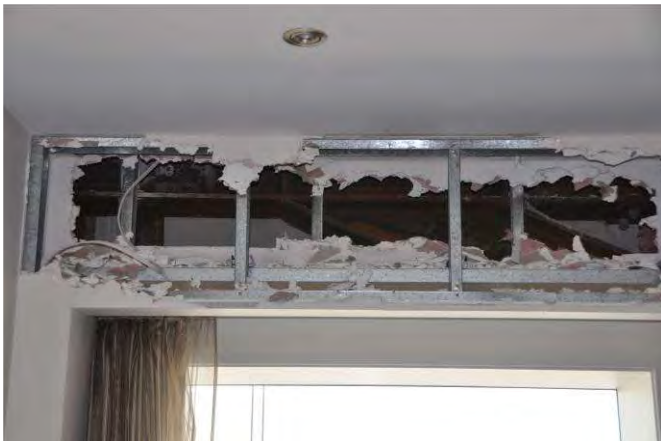
L7, Grid C2, active link

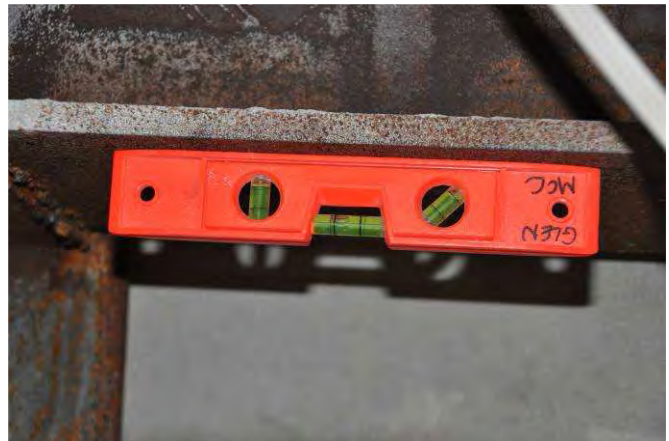
L7, Grid C2, some offset

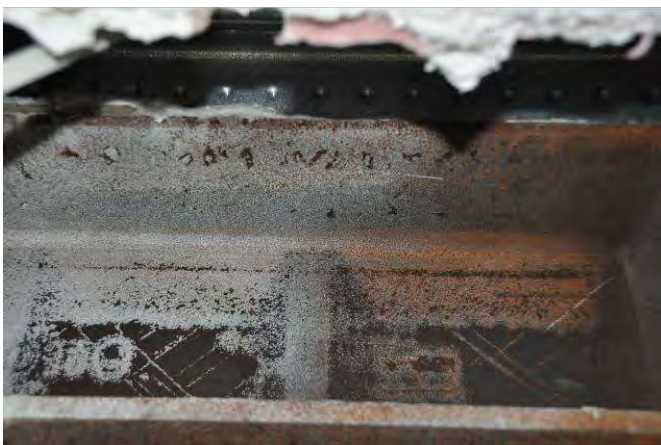
L7, Grid C2, Lueder's lines to active link

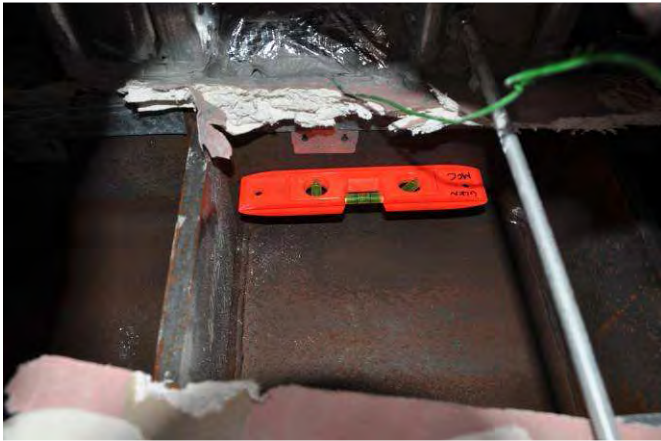
L7, Grid C4(west), no offset

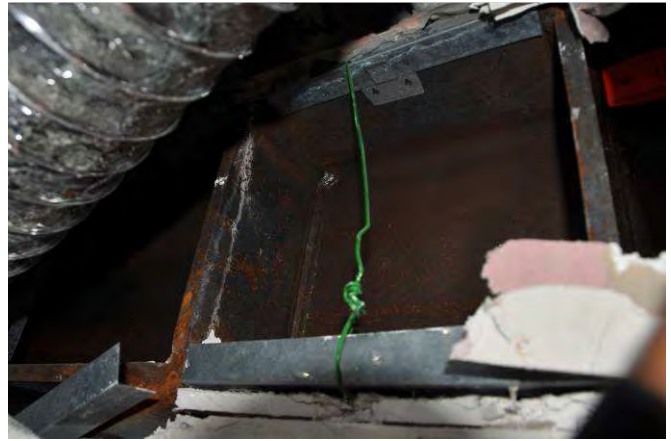
L7, Grid C4(west), active link

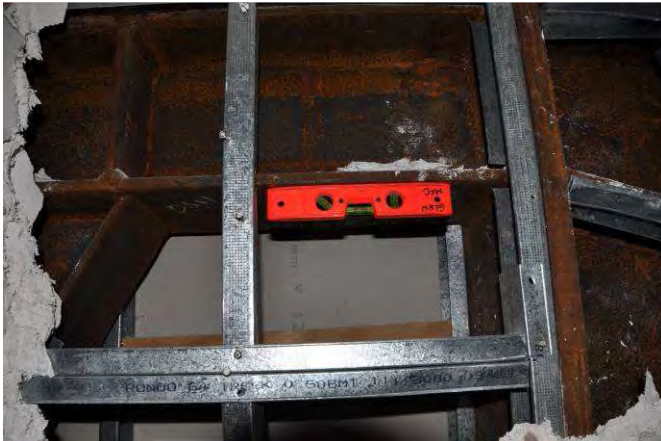
L7, Grid D4(east), no offset

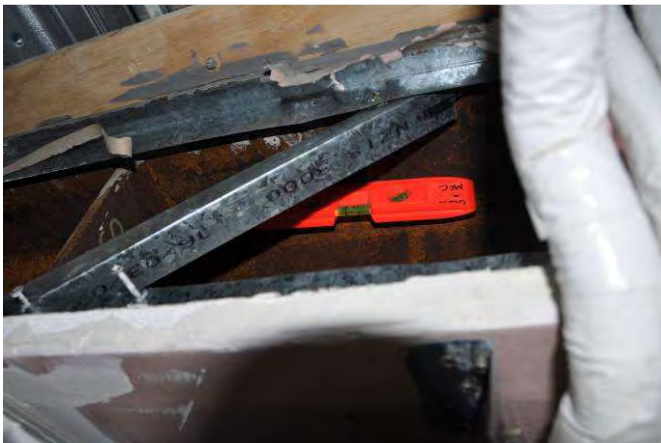
L7, Grid C1/26, minor offset

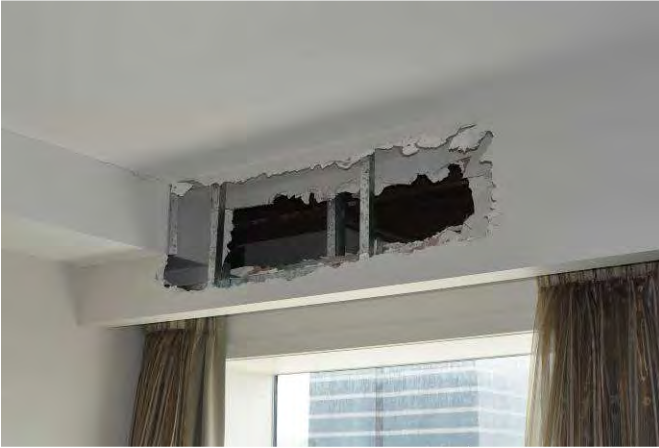
L7, Grid F5, active link

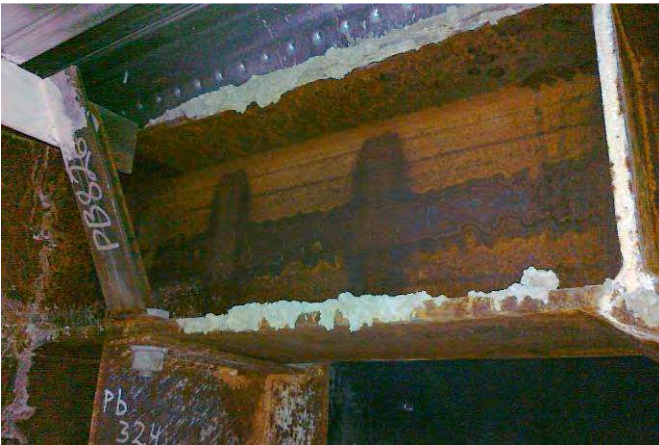
L11, Grid C2, active link

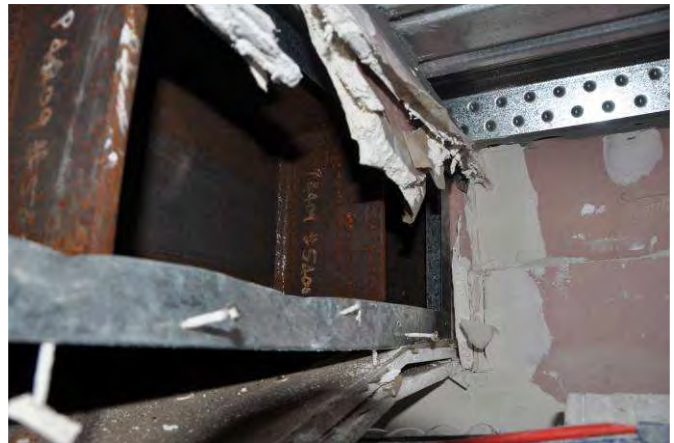
L11, Grid D4(west), active link

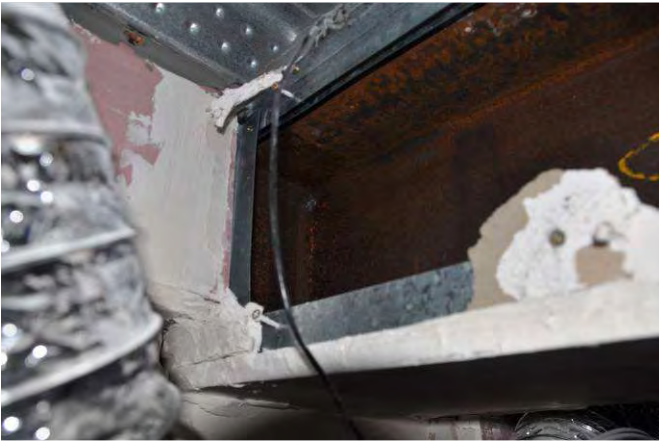
L11, grid C½6, active link

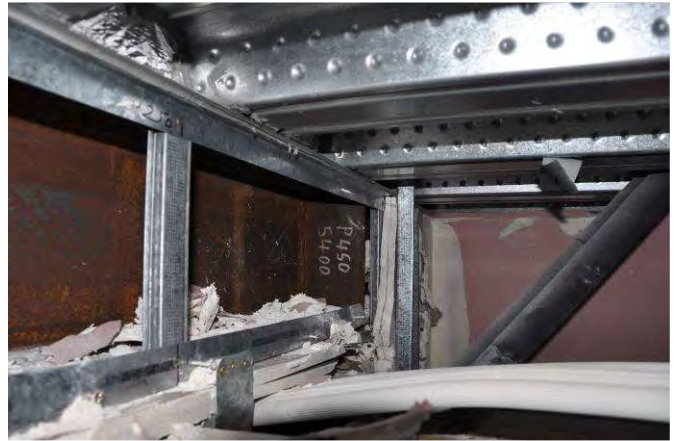
L11, grid C½6, active link

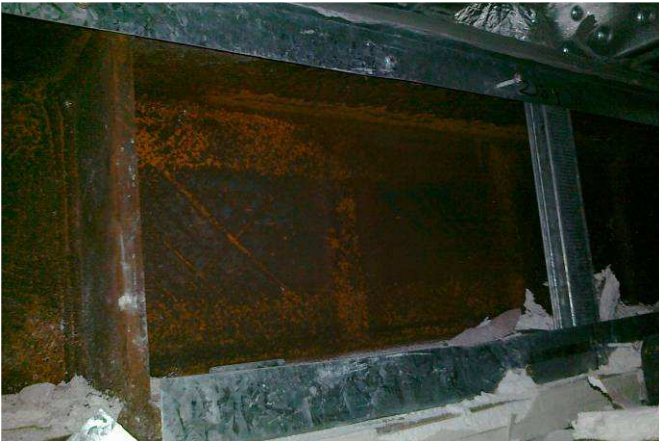
L11, grid C½6, active link

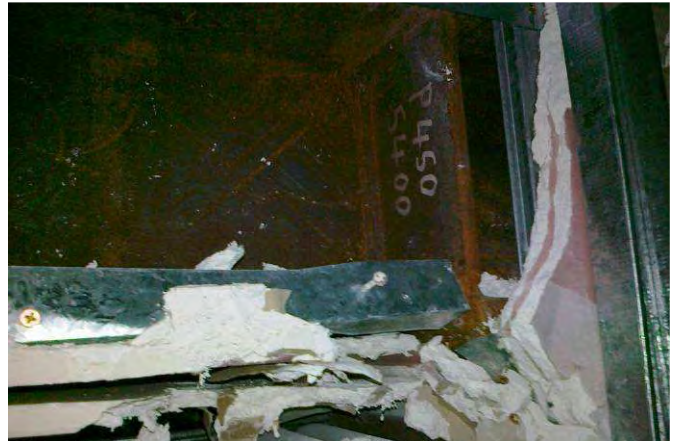
L11, Grid C½6, active link

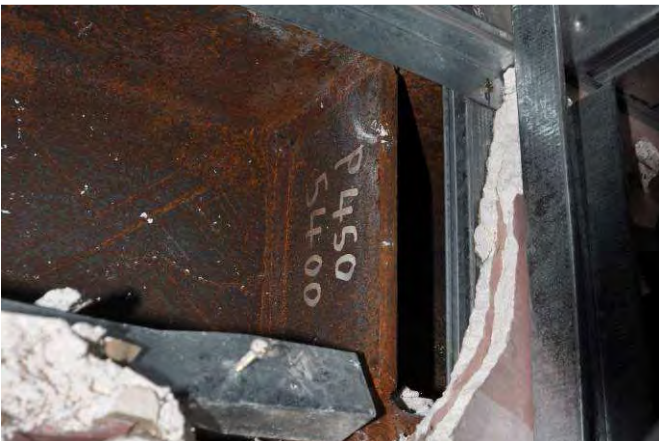
L11, Grid D4(east), active link

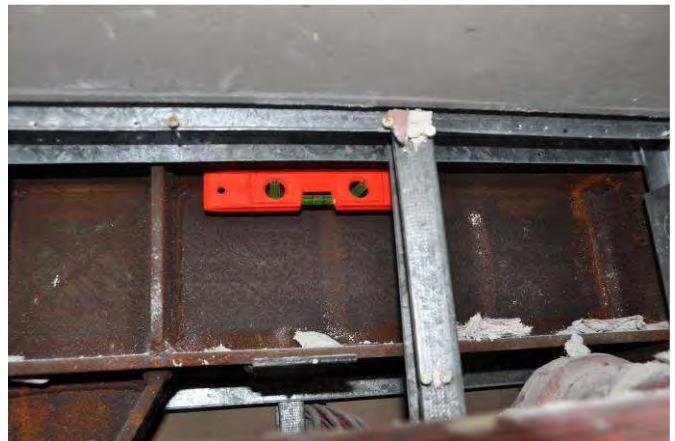
L11, Grid D4, column joint

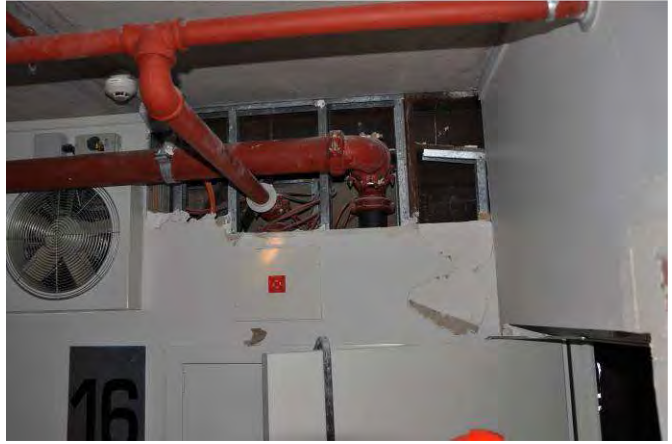
L16, Grid D4(west) active link

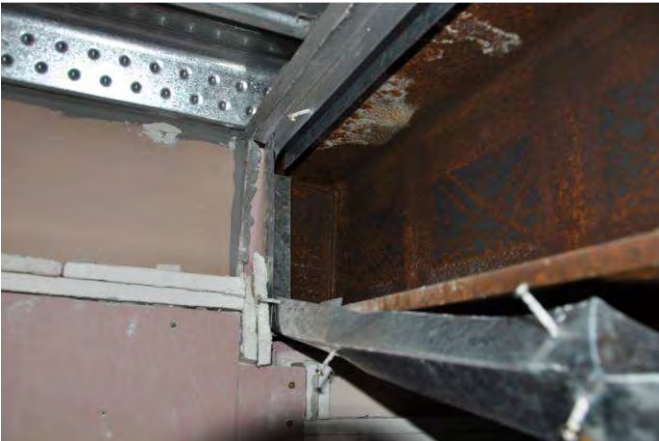
L16, Grid D4(west) active link

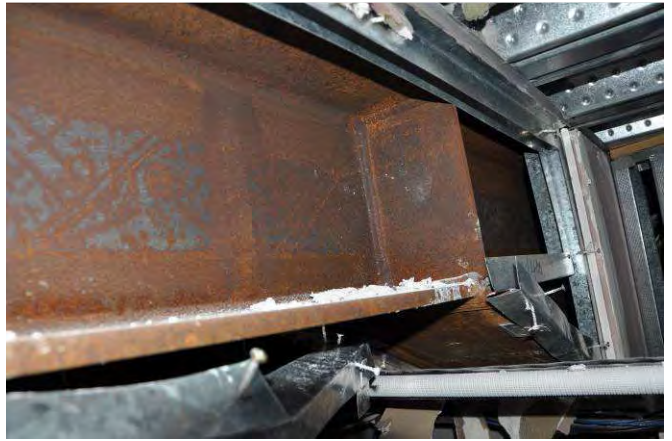
L16, Grid C4(west), active link

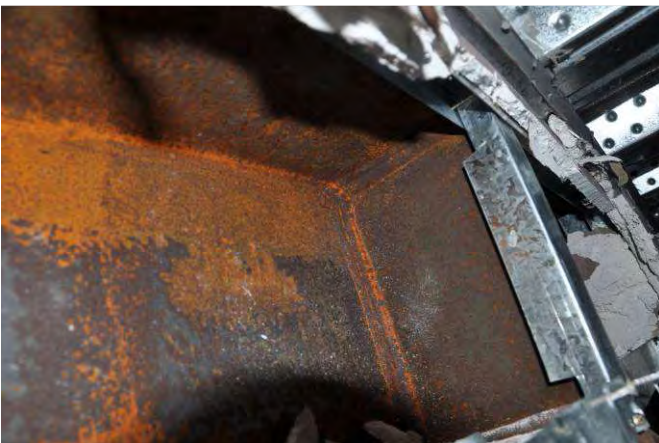
L22, Grid E MRF

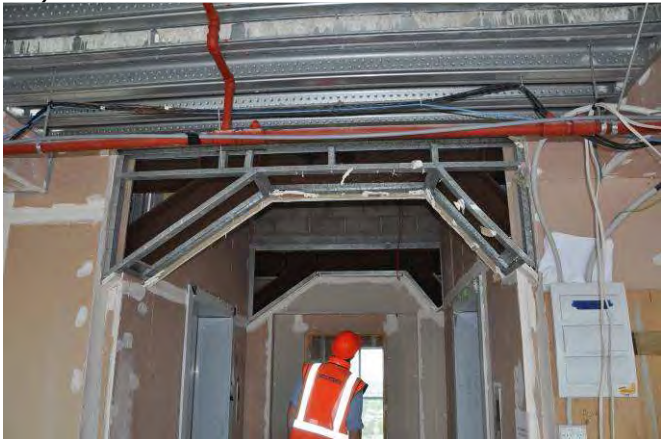
L2, Grid C4(west) active link

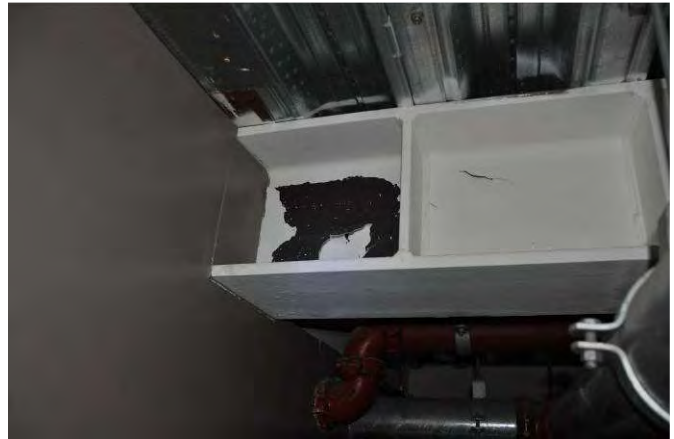
L2, Grid C4(west) active link

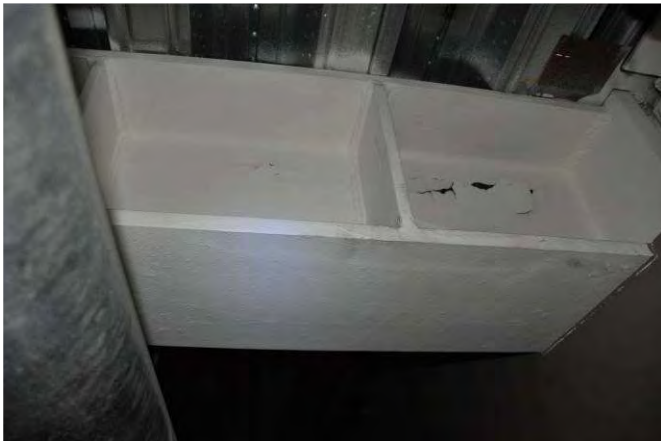
L2, Grid E½1, active link, permanent offset

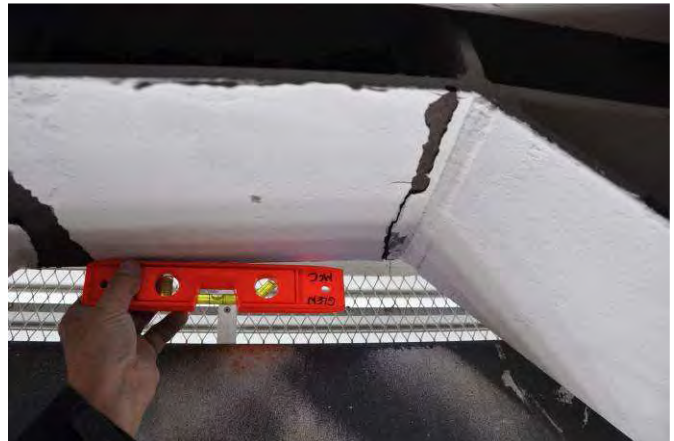
L2, Grid E1/2, active link

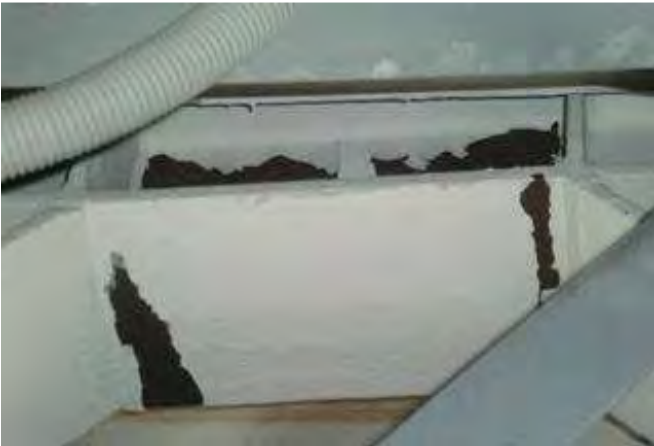
L2, Grid F5, active link

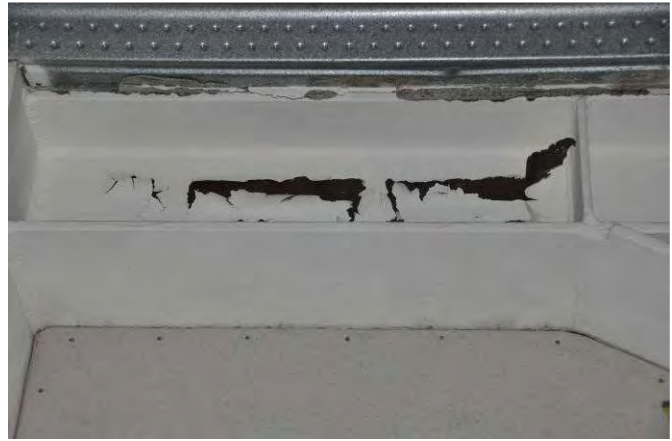
L1, Grid E1, MRF

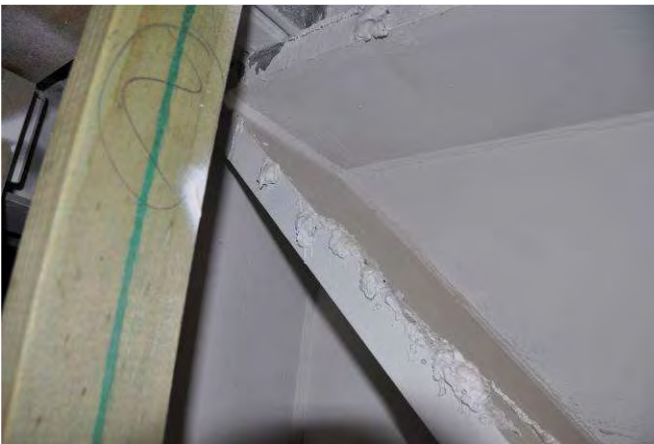
L1, Grid E1, MRF

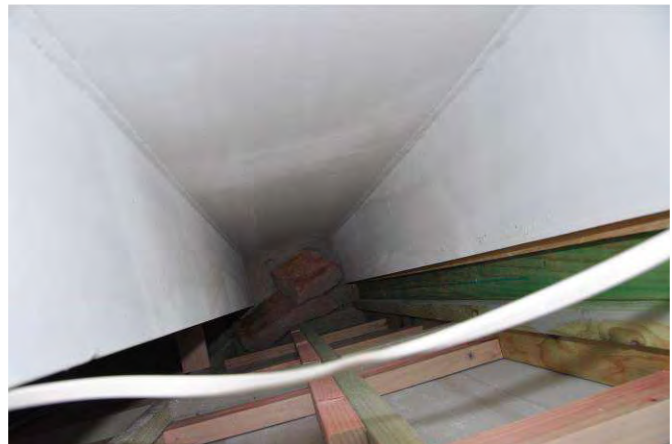
L1, Grid F, MRF

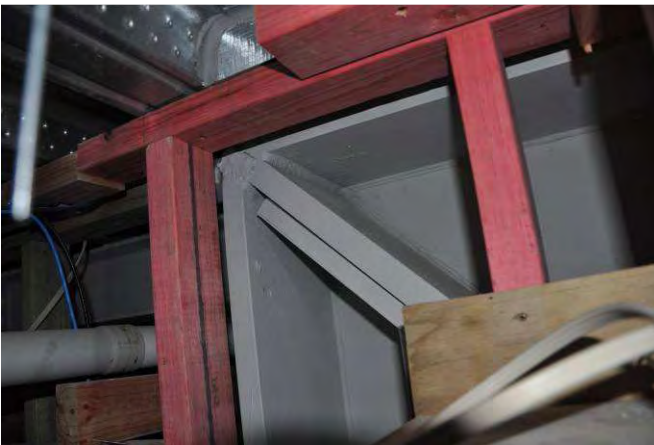
L2 Carstacker crossbraces "unhooked"

- Reinstate carstacker cross braces and top lateral restraints. Re-weld fractured restraints with FPBW, examine other restraints for signs of damage and

repair/reinforce welds as required. Replace and re-fix anchors which have pulled out of the blockwork masonry.

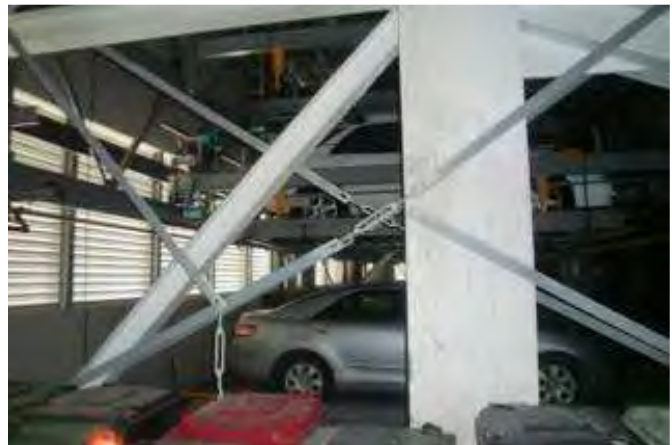
Movement of L2 east wall

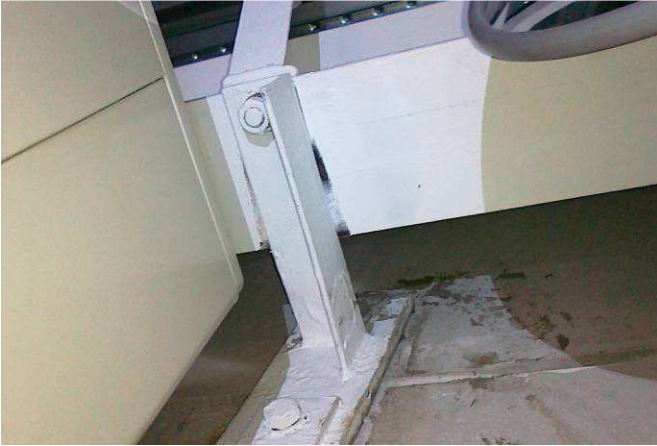
Missing floor anchors at L2 east wall at top of ramp

- Install missing anchors between braces and floor at L2 (top of ramp) on east wall.
- Repair non-structural damage to roofing, flashings, tiles, door frames, ceilings, linings, etc in accordance with manufacturer's recommendations.
- Repair lifts and fire systems in accordance with lift technician's report and fire engineer's report respectively.
- Repaint flaked intumescent paint to exposed steel beams at L2 (prepare steel in accordance with manufacturer's recommendations).

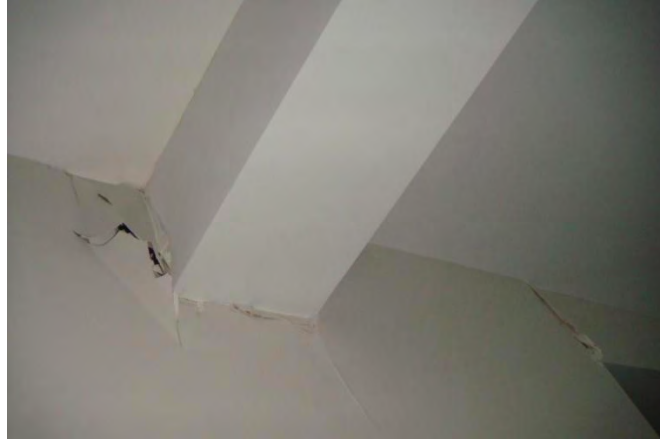
**Sth Room # 801 - Nth - Sth Movement Battering Ram Effect**

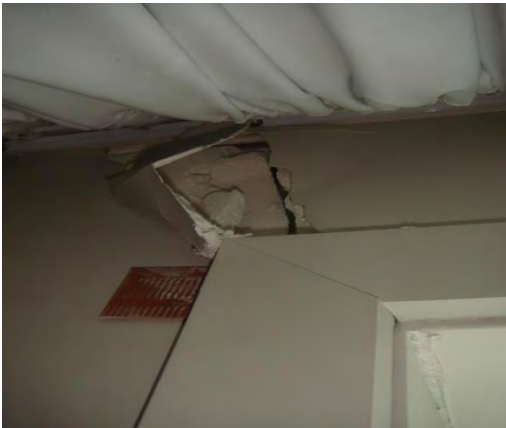
**Nth - Sth Battering Ram I Beam Effect Sth Room #921**

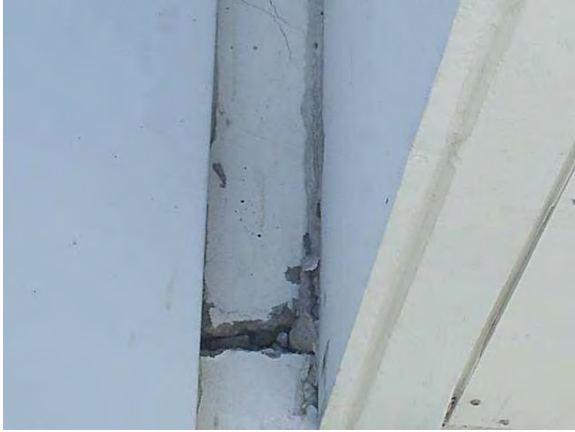
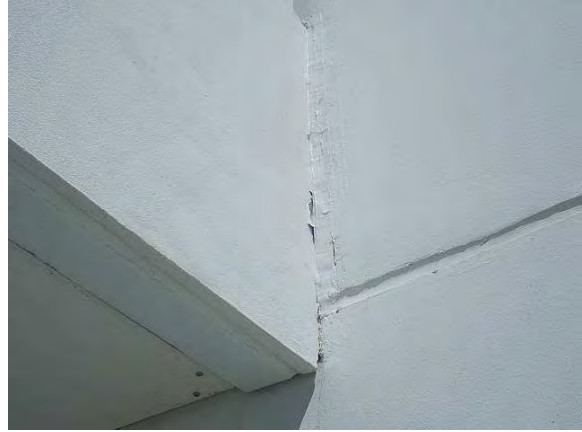
12 East

- The external wall between balcony and corner flashings has sustained damage as you will see by the attached photographs/report. This has occurred on both east and west corners with greater damage from levels 12 to 15.

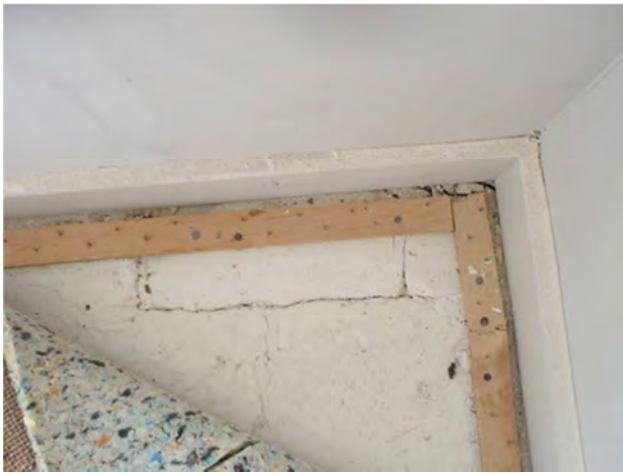
12 East Interior

- There is damage all the way up to level 22, some areas greater than others.
- The carpets will need to be lifted and floors inspected for cracks and damage. I have attached photographs of damaged floor areas in the corners where we have already inspected.

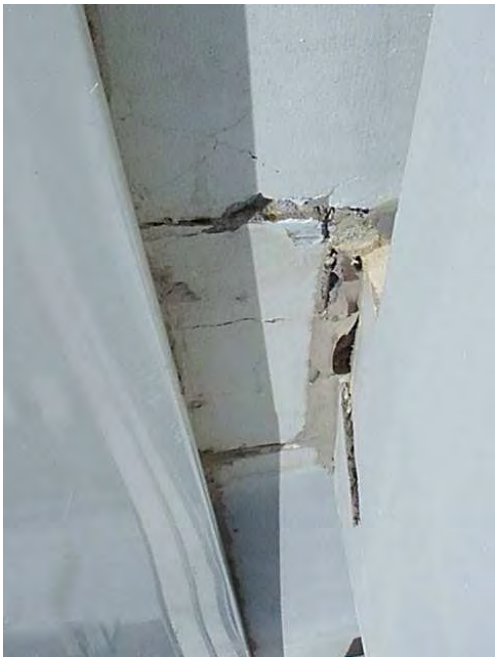
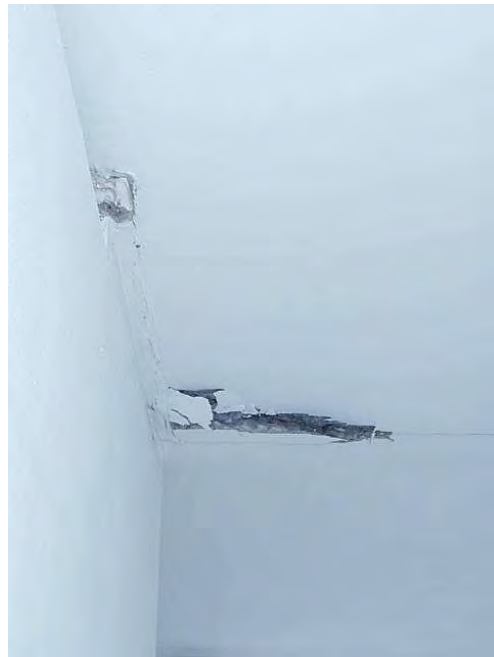
- 15 East has sustained damage and requires the gib to be removed on the both corners of the north and east walls of the kitchen/lounge – I would advise this to be done in most of the rooms that show external damage of this nature.

- Repairs will need to be carried out hanging in a harness from a rope due to poor accessibility. This will be very time consuming.

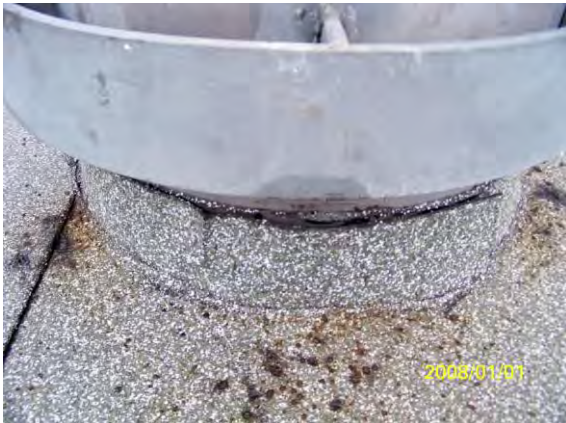
**Top Base Roof Ring Water Seal Broken**

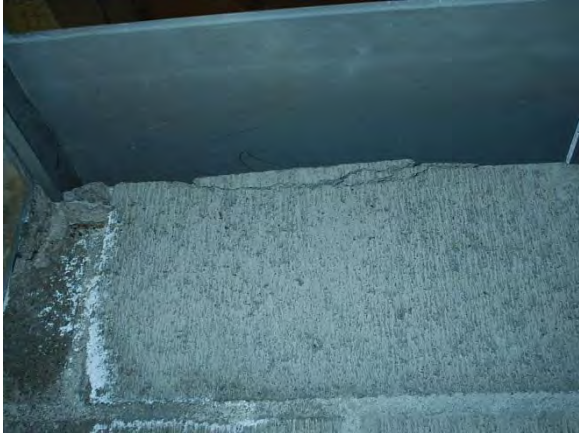
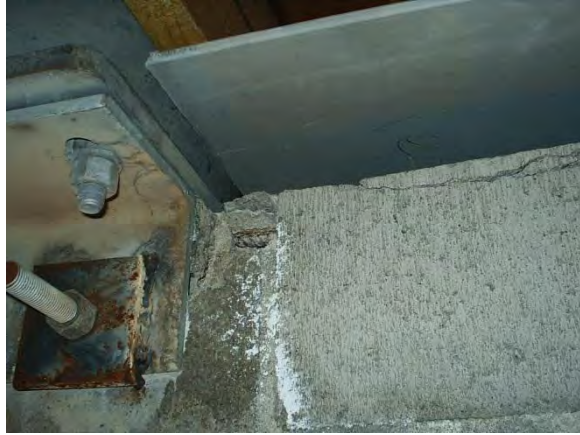
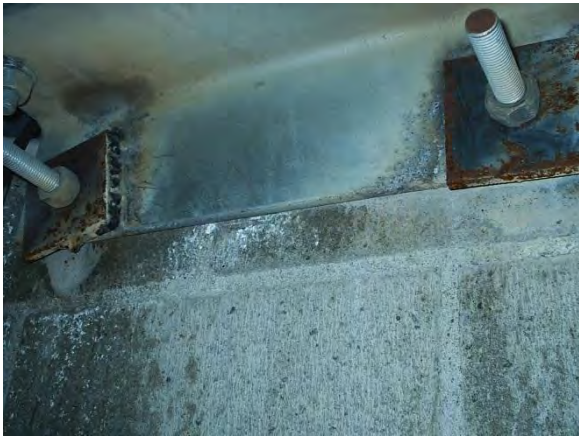
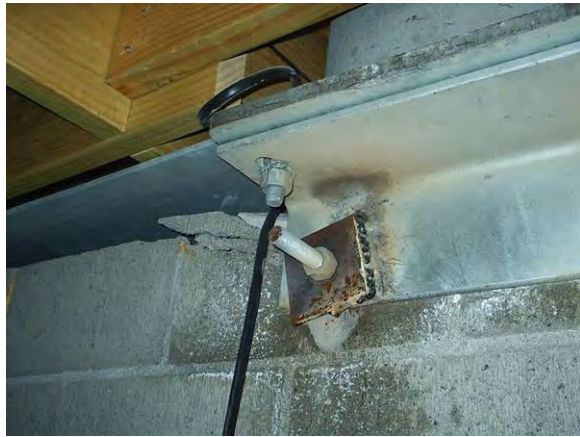
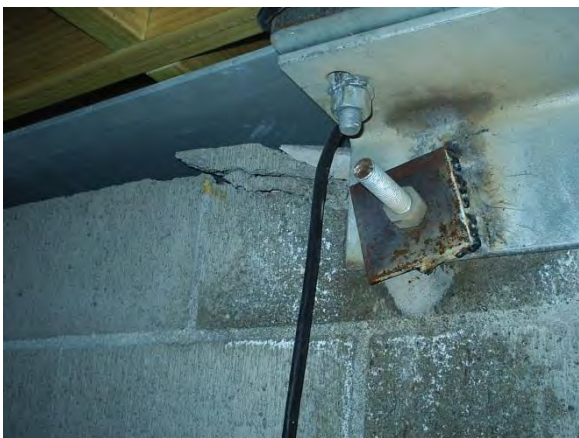
## FLAG POLE BASE MOUNT

**Mostly Fractured Concrete Block & Base Mount Bolt Mounts below Roof**
