BUILDING SURVEY		Date	Report No.	File																								
NAME & ADDRESS	Name of Building Street		No.	9/2																								
OWNERSHIP	Owned <u>Leasehold</u> <u>Leased</u>		Area	2555 sq. ft.																								
PLANS	Occupancy		8 hr / 24 hr	5 day / 7 day																								
USED AS	Office, Workroom, Factory, Commercial, Storage, Other																											
STRUCTURE	No. of Storeys <u>Part II</u> Mass <u>Basement</u> Building Dimensions: Width <u>35'</u> Length <u>73'</u> Height Foundation Type: Strip Footing <u>_____</u> Ratt <u>_____</u> Column pads <u>_____</u> Piles <u>_____</u> Caissons <u>_____</u> Ground Conditions: Rock <u>_____</u> Gravel <u>_____</u> Sand <u>_____</u> Silt <u>_____</u> Clay <u>_____</u> Fill <u>_____</u> Frame: Steel <u>_____</u> R.C. <u>_____</u> Partial <u>_____</u> Exterior Panels: Brick <u>_____</u> Wood <u>_____</u> Other <u>_____</u> Exterior Wall Veneers: Brick <u>_____</u> Stone <u>_____</u> Other <u>_____</u> Remarks <u>_____</u> Condition <u>_____</u> Bearing Wall: Brick <u>_____</u> Stone <u>_____</u> Other <u>_____</u> Masonry wall bands <u>_____</u> Floor: R.C. <u>_____</u> Wood <u>_____</u> Other <u>_____</u> Eff. Diaph.

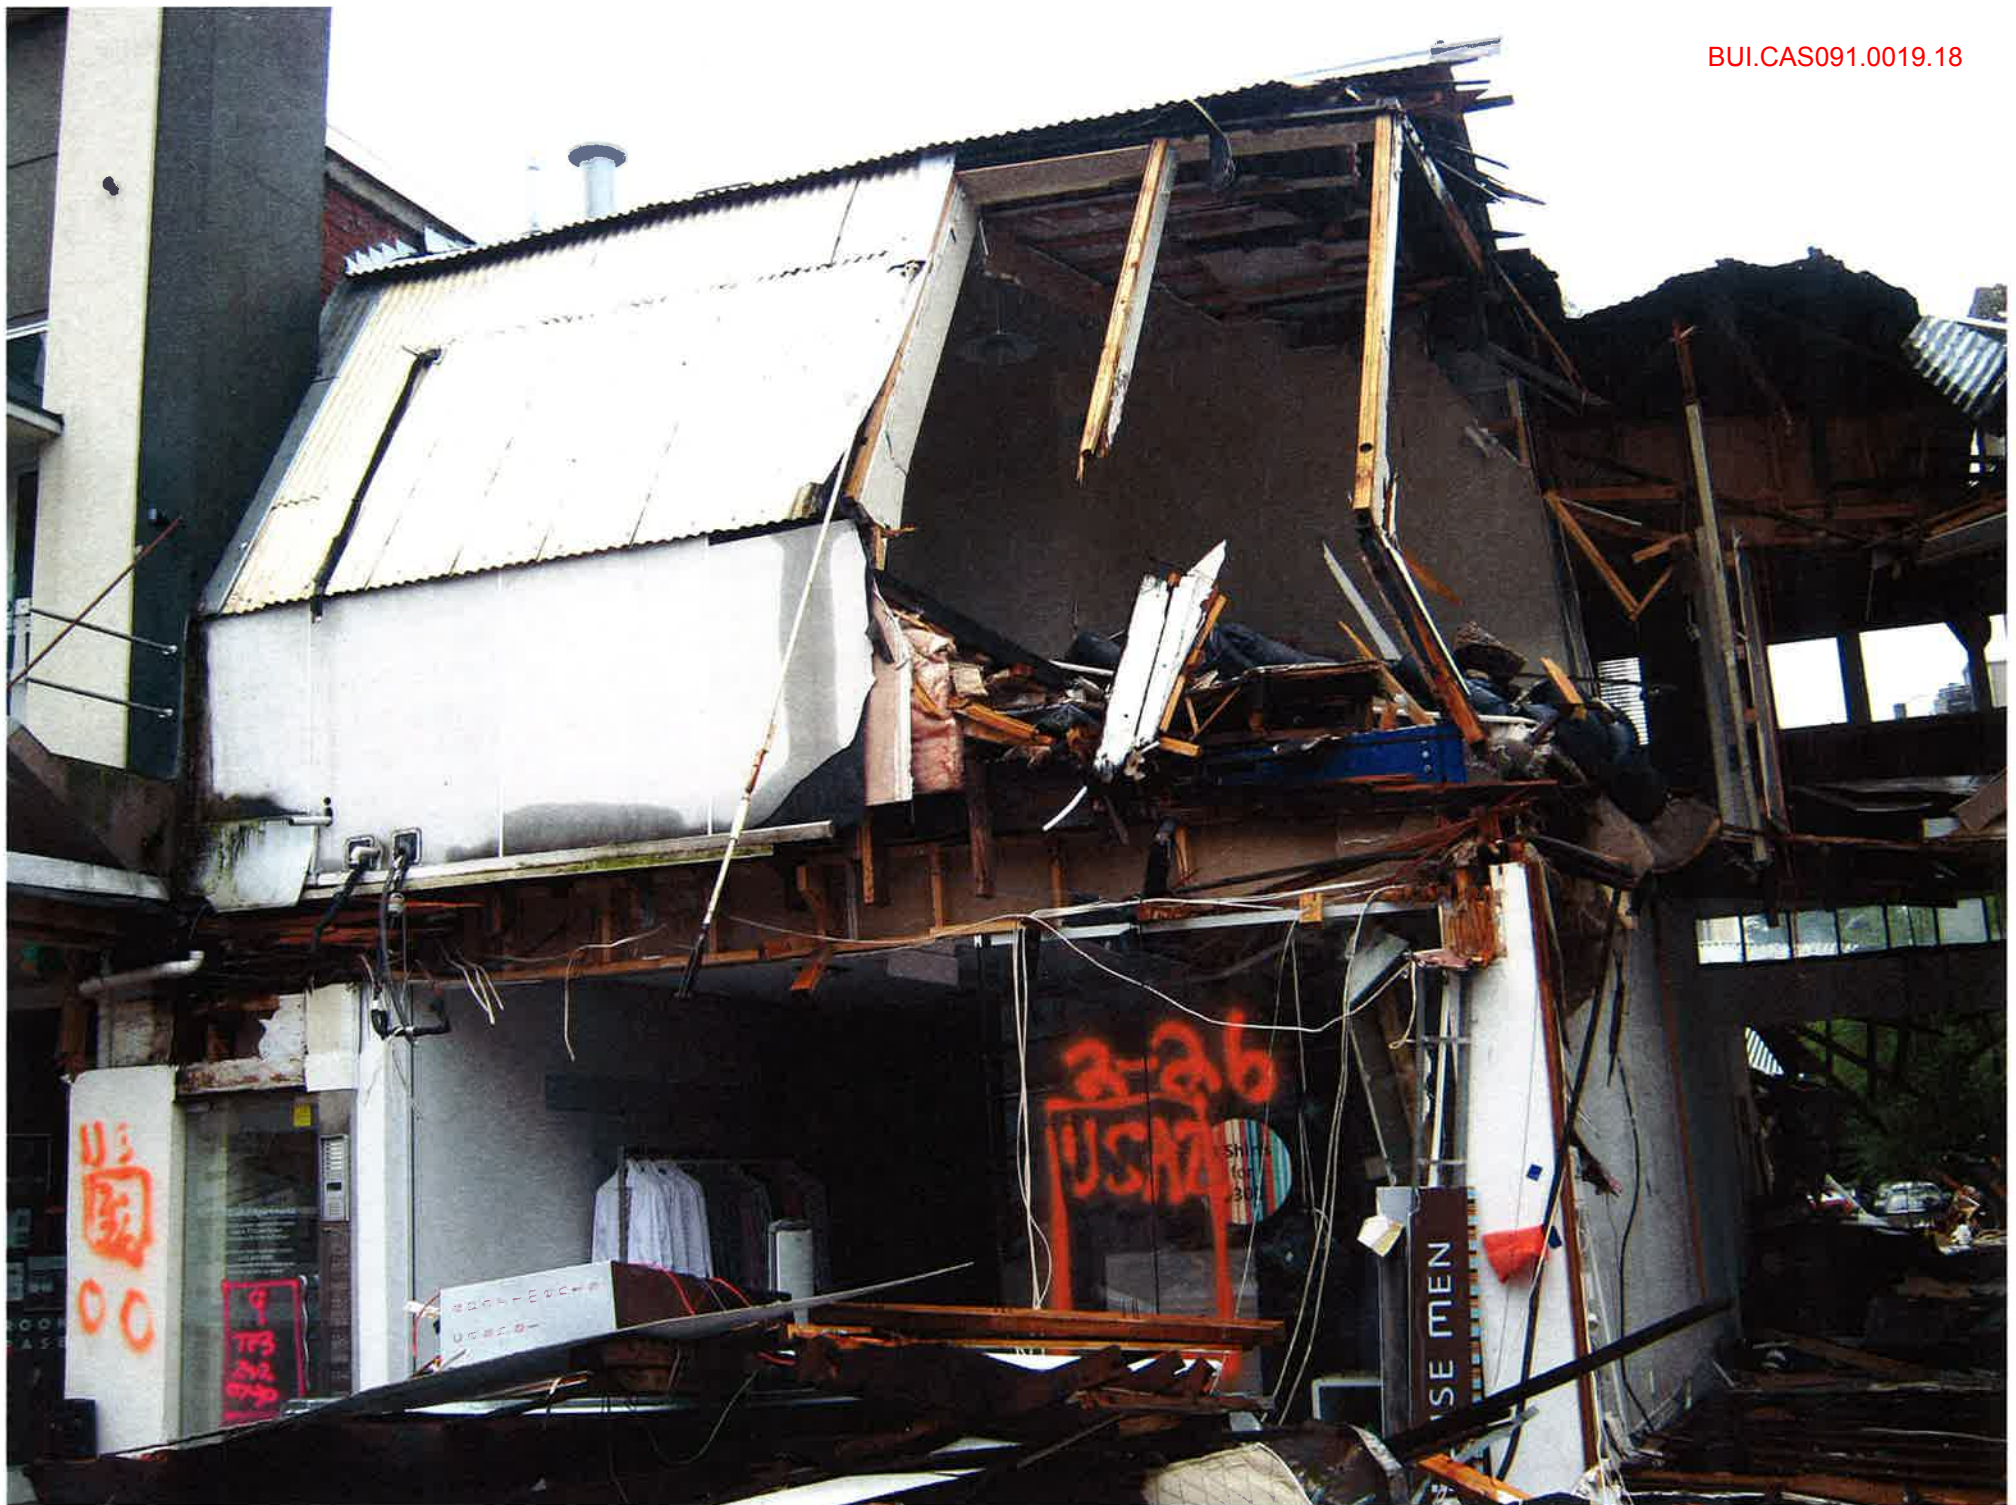
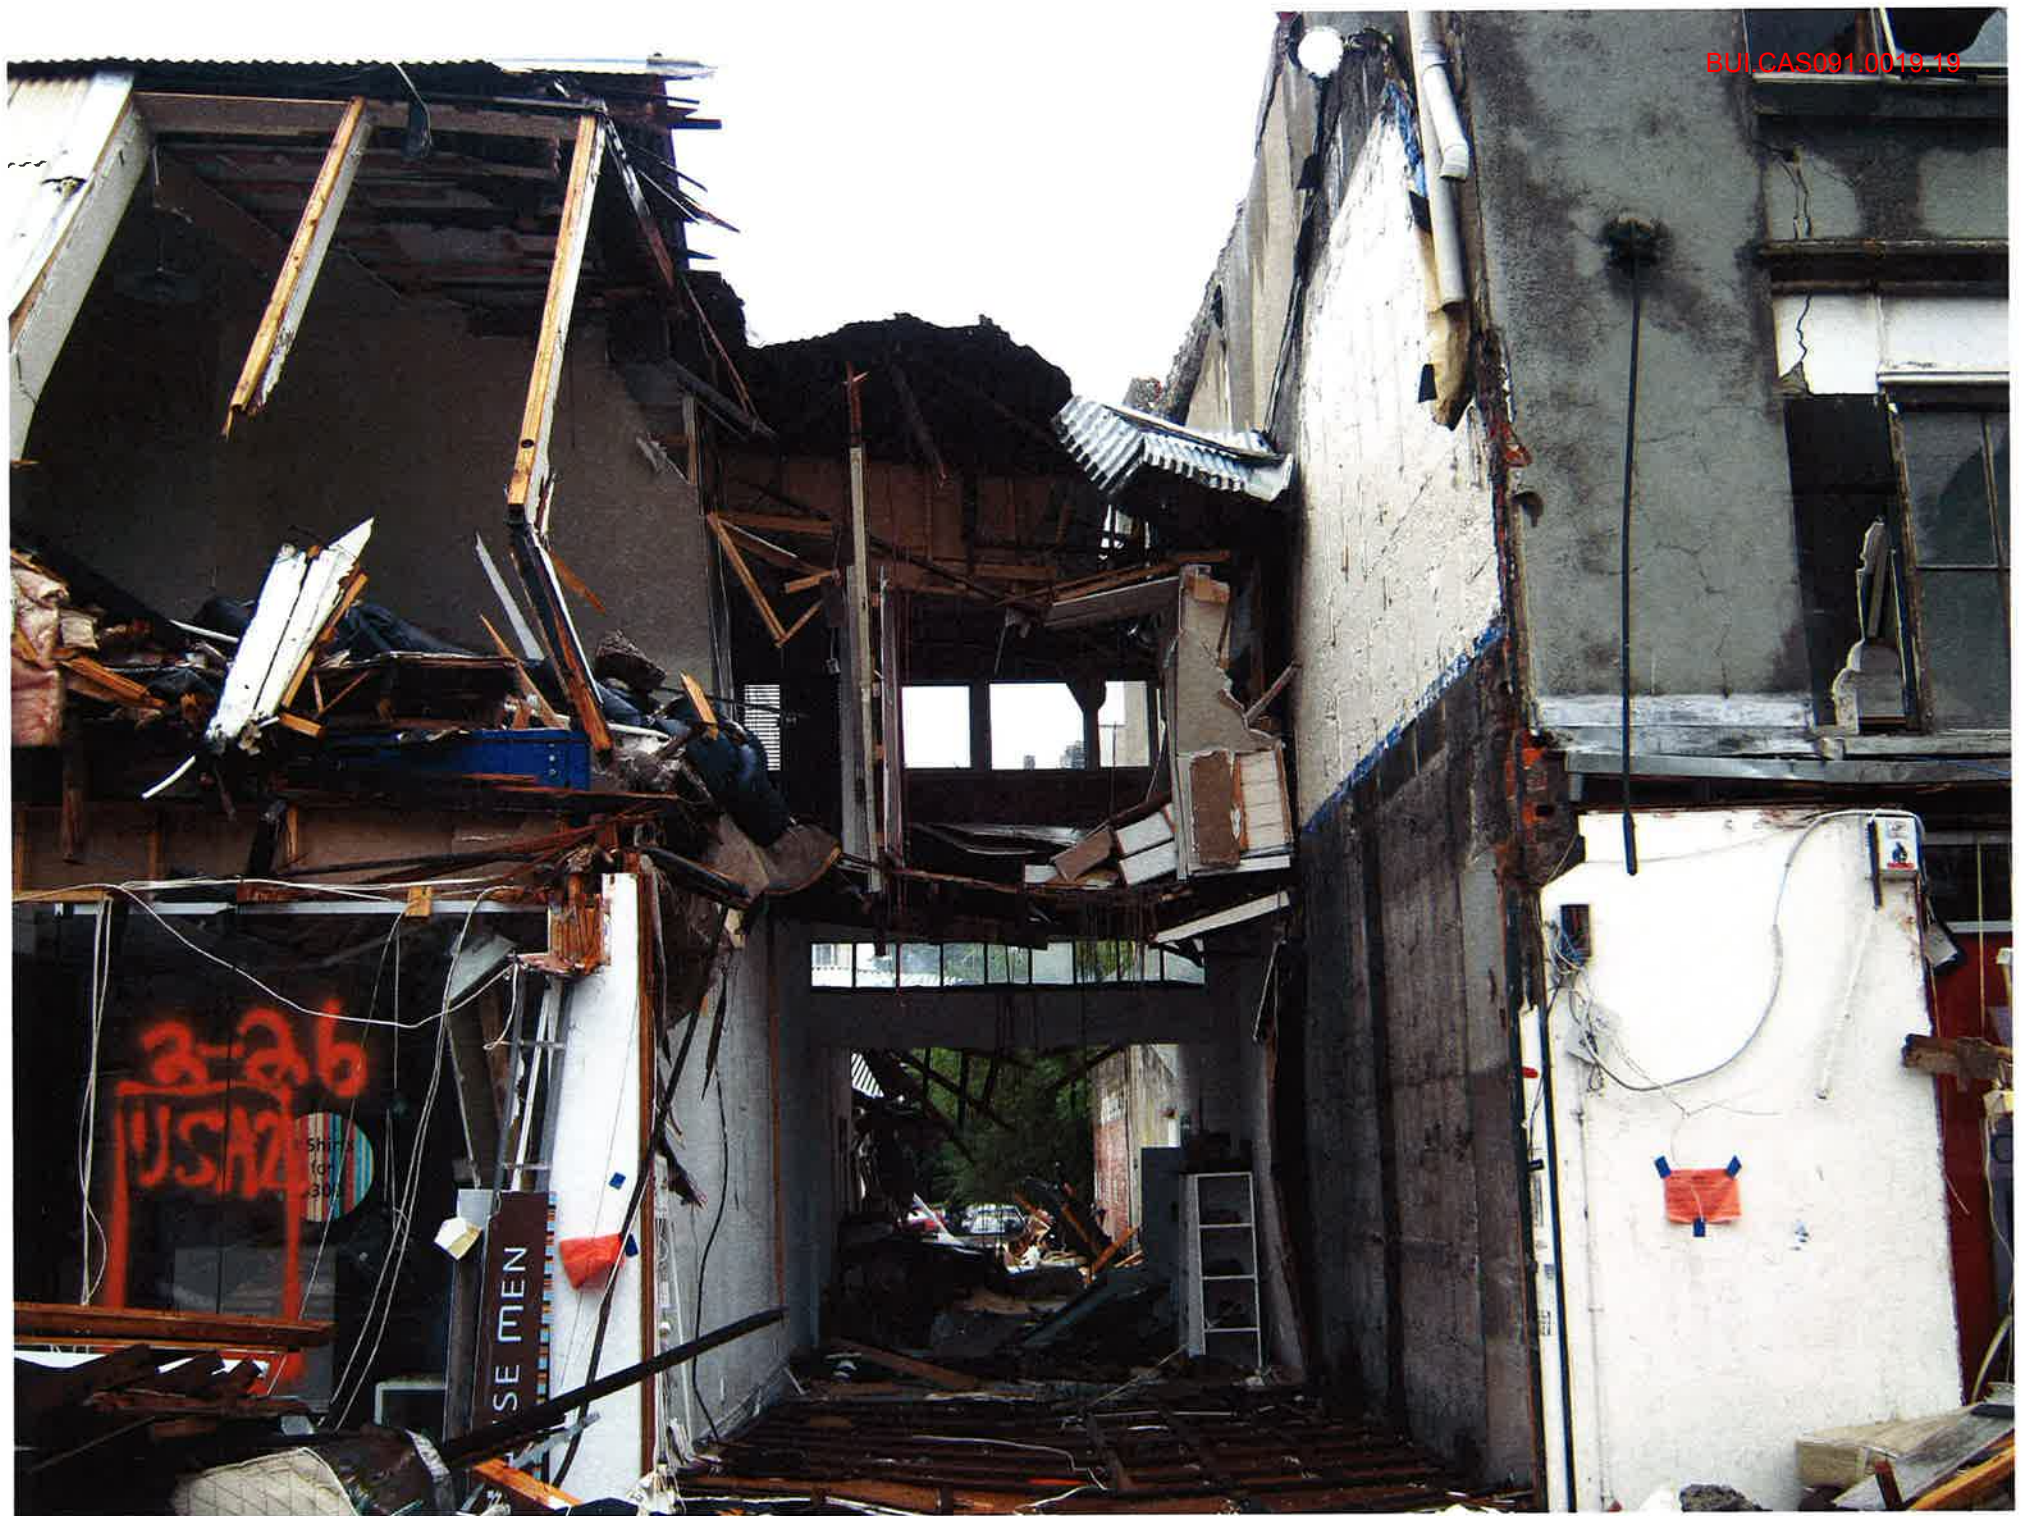
The building has sustained severe damage, most notably the loss of the building frontage and side adjacent to 91 Cashel St; refer photographs following. It is evident that this damage has been caused by the partial collapse of 91 Cashel St. The roof support has also been removed along most of the front of the building.

At present, 91 Cashel Street presents an overhead falling hazard to your building.

front and damage to adjacent buildings

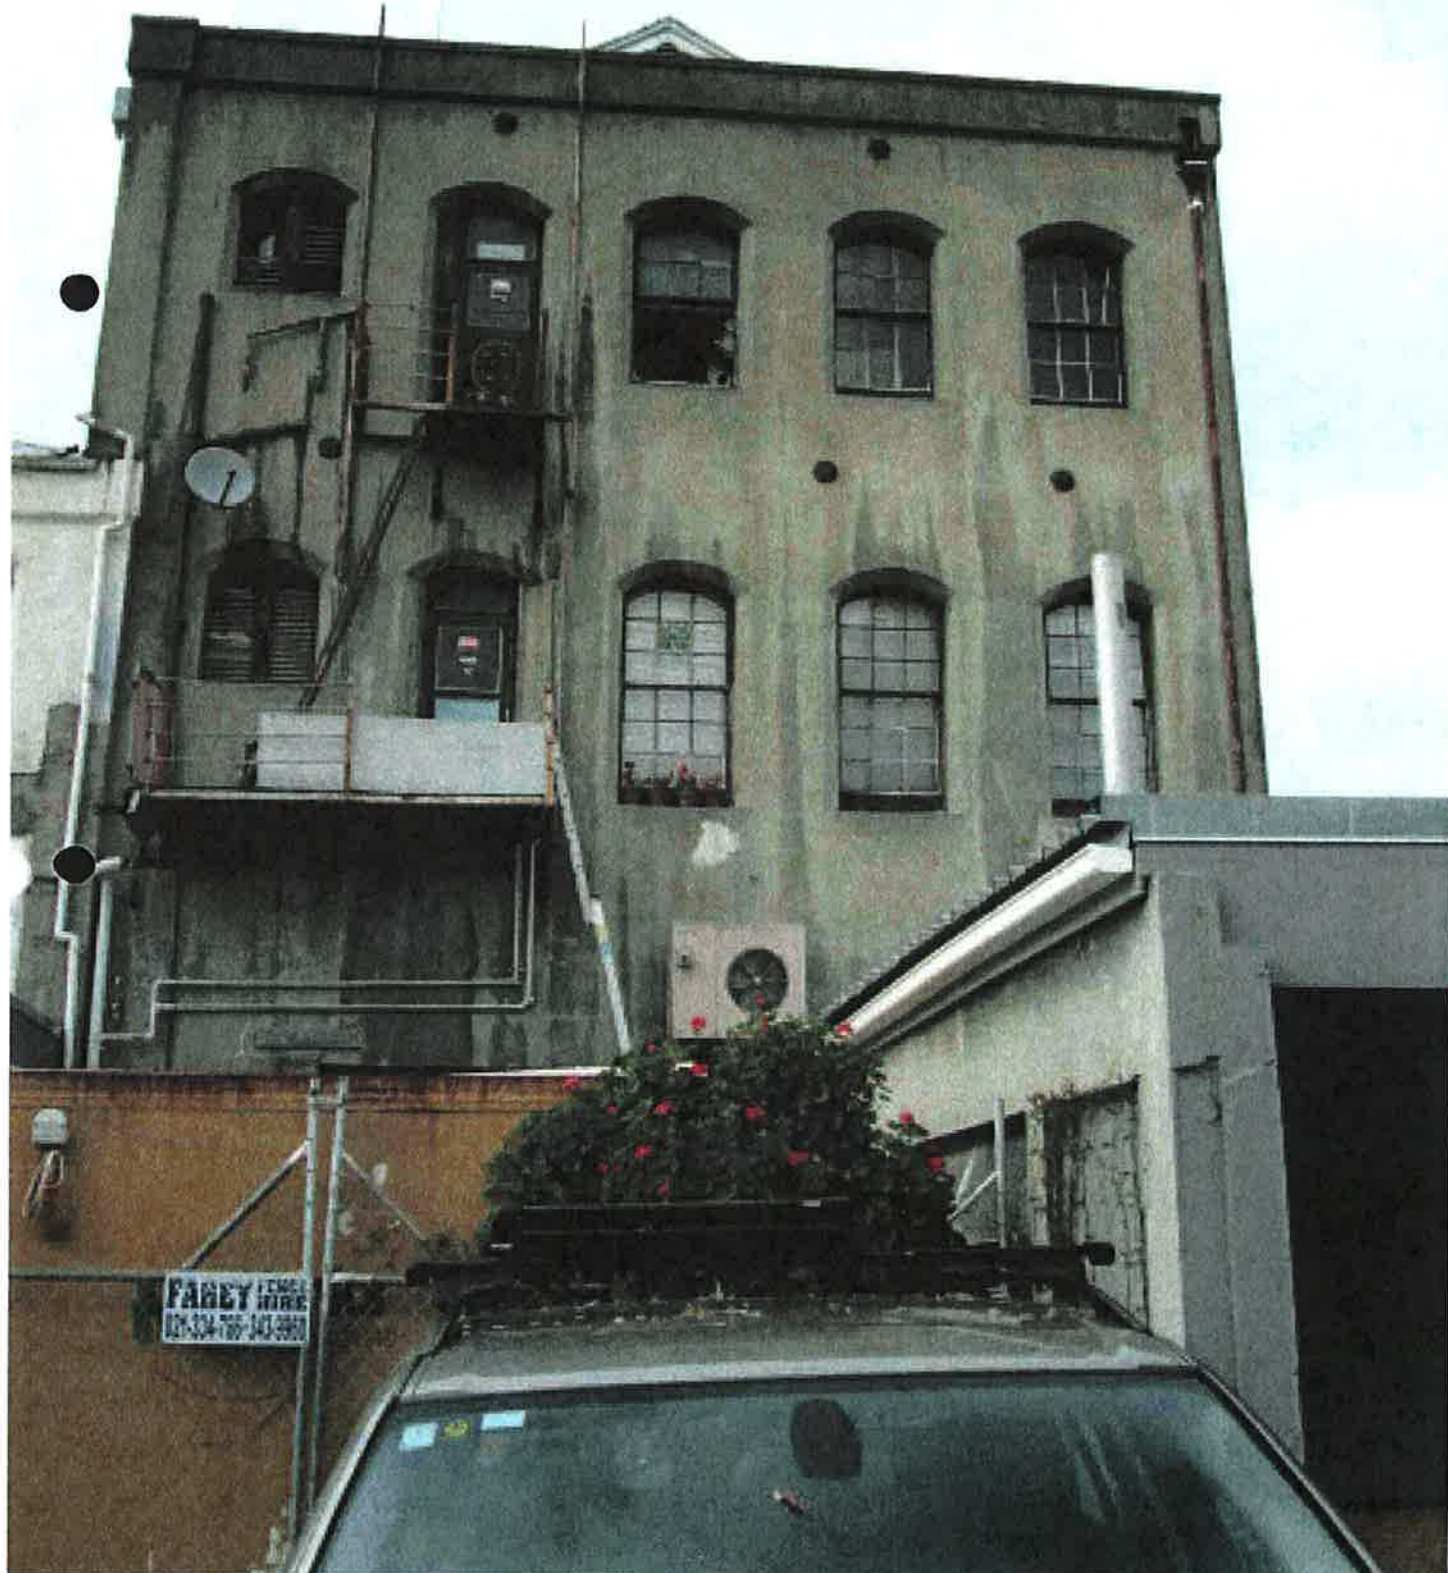
check by engineer - hairline crack in structural wall
