**Christchurch Earthquake
CBD Building Performance Technical Investigation**

**Report on the Structural Performance
of the
Hotel Grand Chancellor
in the
Earthquake of 22 February 2011**

Prepared By:
Dunning Thornton Consultants Ltd

Final: 26 September 2011

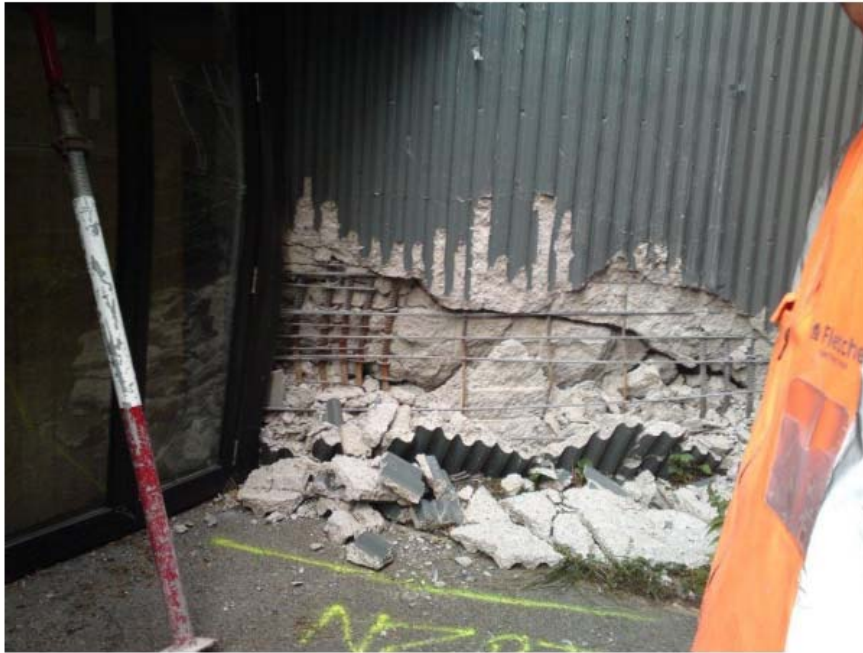
Photo 11 - Similar Shearwall Failure
Not the Hotel Grand Chancellor

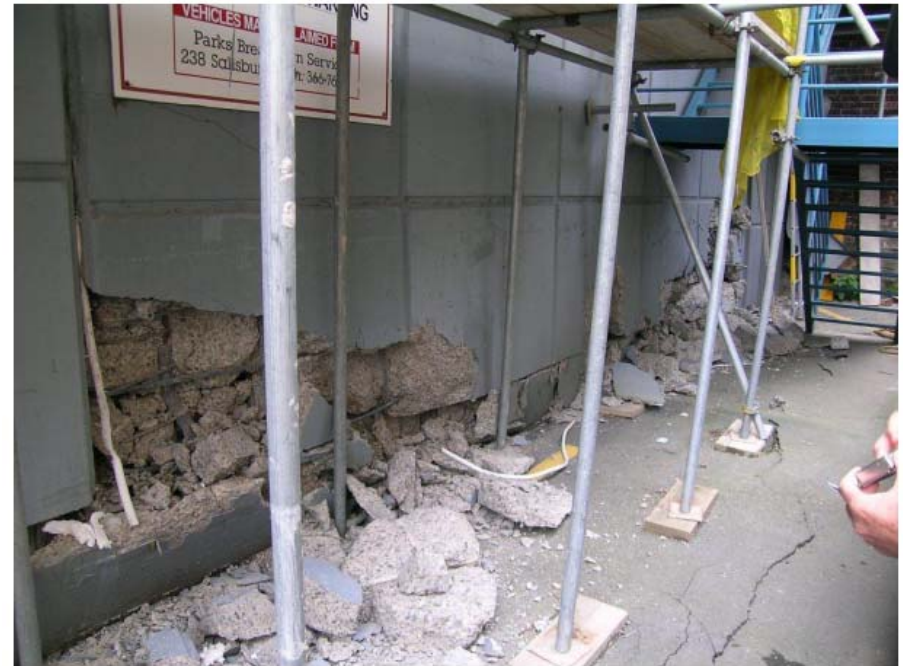
Photo 12 - Similar Shearwall Failure
Not the Hotel Grand Chancellor
